Access Compliance Report

Public Rights-of-Way

(Curb Ramps)

| Intersection ID: 52462 | Main Street: ST_ANDREWS_HOMES_PL | Cross Street: CENTRAL_AV | Location: NW |

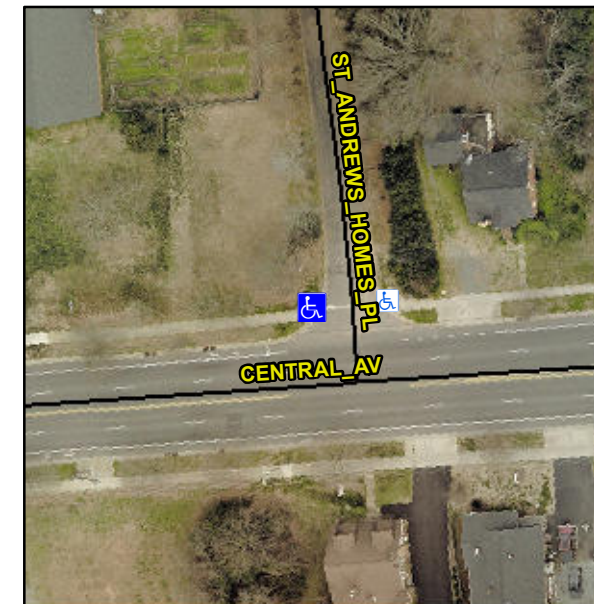
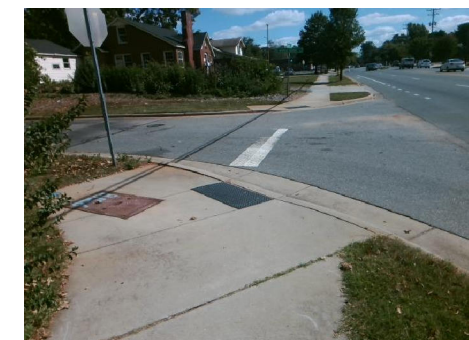
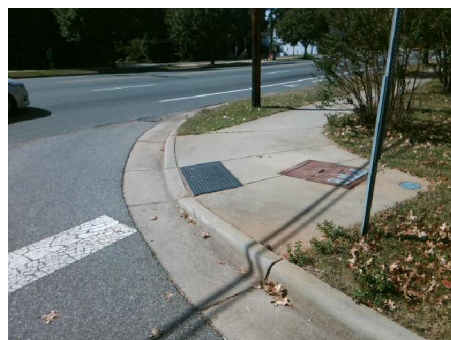
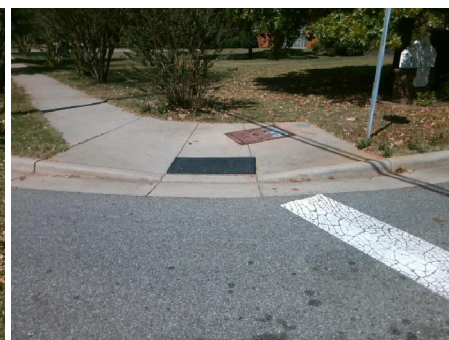
| ADA ID: 40FFC74025A8 | Ramp Type: Perp | Initial Pass/Fail: Fail | Overall Compliance: No |

Not Found, R304.5.1, R304.5.3

| Compliance | Description | Data | Compliance | Description | Data |
|---|---|---|---|---|---|
| No | Ramp Width (in) | 42.0 | No | Ramp XSlope (%) | 3.4 |

Remove & Replace Entire Ramp.
