Access Compliance Report

Public Rights-of-Way

(Curb Ramps)

Intersection ID: N/A	Main Street: TRAILMOOR_RD	Cross Street: BRECKFIELD_CT	Location: SW
ADA ID: 4107D7A38443	Ramp Type: BlendTrans1	Initial Pass/Fail: Fail	Overall Compliance: No
Severity Score: 10			
Codes/Mitigation Info/Possible Solution		Field Measurements/Component Compliance

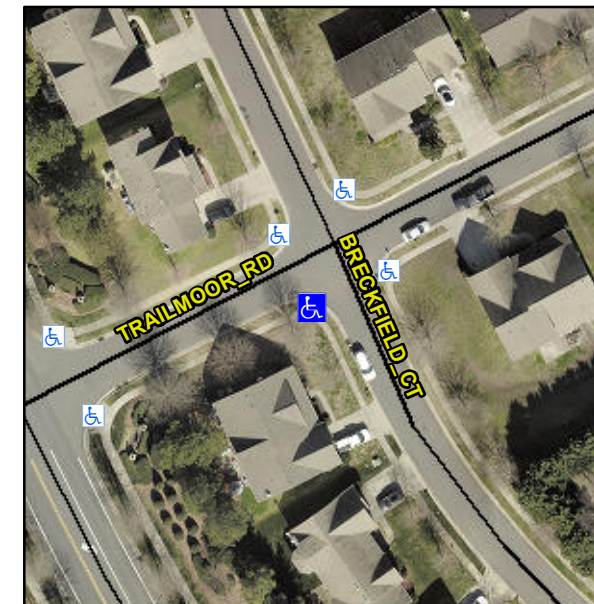
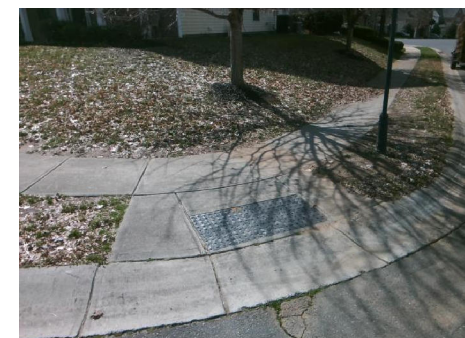
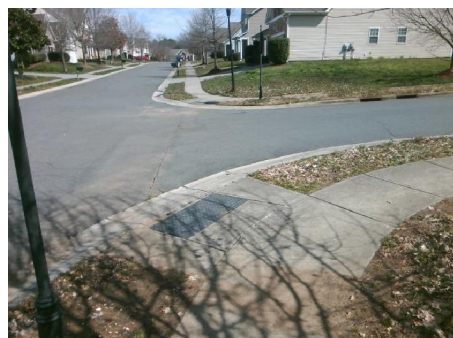
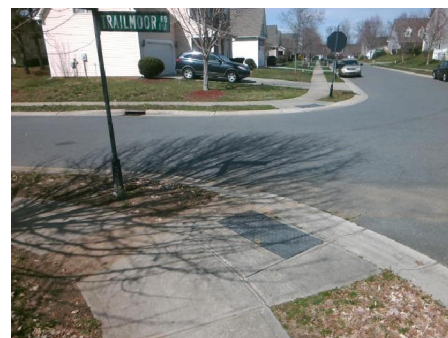
Compliance	Description	Data	Compliance	Description	Data
N/A	Ramp Length (in)	45.0	Yes	BlendTrans Slope (%)	4.8
No	Ramp Width (in)	46.0	No	BlendTrans XSlope (%)	3.5
N/A	Flare Type LT	N/A	N/A	Flare Type RT	N/A
N/A	Flare Slope LT (%)	N/A	N/A	Flare Slope RT (%)	N/A
N/A	Flare Traversable LT?	N/A	N/A	Flare Traversable RT?	N/A
N/A	Landing Length (in)	N/A	N/A	DWS Provided?	N/A
N/A	Landing Width (in)	N/A	N/A	DWS Contrast?	N/A
N/A	Landing Slope (%)	N/A	N/A	DWS Length (in)	N/A
N/A	Landing X Slope (%)	N/A	N/A	DWS Full Width?	N/A
N/A	Landing Curb? (Y/N)	N/A	N/A	DWS Offset (in)	N/A
N/A	Shared Landing?	N/A			
N/A	Gutter Ponding?	N/A	N/A	Gutter Slope (%)	N/A
N/A	Gutter Lip Ht (in)	N/A	N/A	Gutter X Slope (%)	N/A
N/A	Painted X Walk1?	No	N/A	Painted X Walk2?	No
	X Walk 1 Direction	To NE		X Walk 2 Direction	To NW
	X Walk 1 Width (in)	N/A		X Walk 2 Width (in)	N/A
	X Walk 1 Slope (%)	0.4		X Walk 2 Slope (%)	1.2
	X Walk 1 X Slope (%)	3.9		X Walk 2 X Slope (%)	1.6

N/A	Ramp inside XWalk1?	N/A	N/A	Ramp inside XWalk2?	N/A
	Road Slope (%)	2.0		Clear Space?	N/A
	Road X Slope (%)	0.4	N/A	Clear Space to XWalk (in)	N/A
N/A	Any Obstructions?	N/A	N/A	Storm Grate/Utility Hazard?	N/A
	Obstruction Type			Storm Grate/Utility Type	
		N/A			N/A
			Yes	Surface Condition? (G/P)	Good
			N/A	Curb Slope (%)	3.4

Remove & Replace Curb Ramp With Two New Directional Ramps or Equivalent.

R304.5.1, R304.5.3
