Access Compliance Report

Public Rights-of-Way

(Curb Ramps)

| Intersection ID: 10187 | Main Street: ANDERSON_ST | Cross Street: SPENCER_ST | Location: NW |

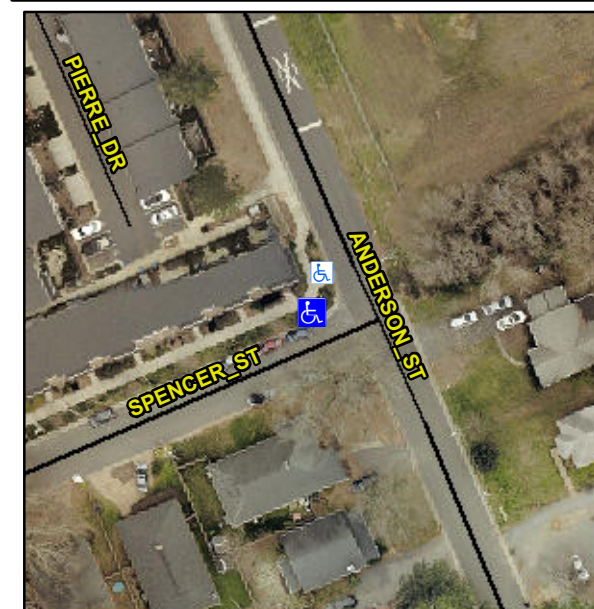
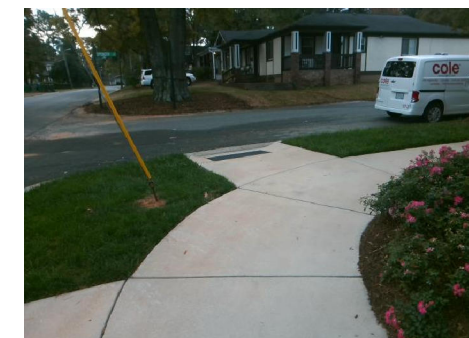
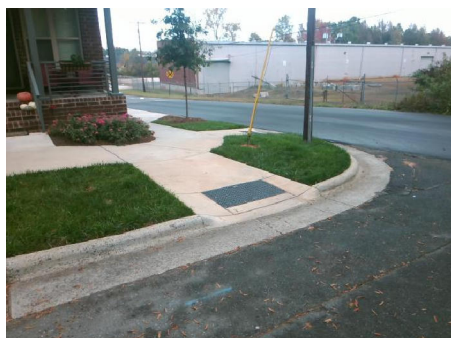
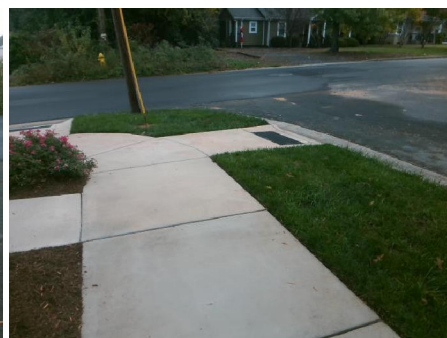
| ADA ID: 410EB760A497 | Ramp Type: Perp | Initial Pass/Fail: Fail | Overall Compliance: No |

Not Found, R304.5.1, R304.2.2, R304.5.3

| Compliance | Description | Data | Compliance | Description | Data |
|---|---|---|---|---|---|
| N/A | Ramp Length (in) | 96.0 | No | Ramp Slope (%) | 8.4 |
| No | Ramp Width (in) | 47.0 | No | Ramp XSlope (%) | 5.3 |

Remove & Replace Entire Ramp.
