Access Compliance Report Public Rights-of-Way (Curb Ramps)

Intersection ID: 9865 Main Street: FREEDOM_DR Cross Street: N_I-85_RA Location: SE

ADA ID: 411310AFC6F6 Ramp Type: Perp Initial Pass/Fail: Fail Overall Compliance: No Severity Score: 21.25

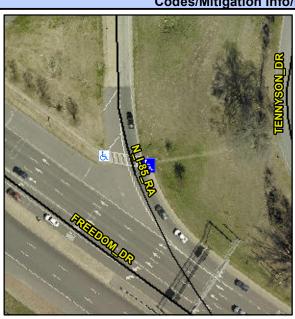
Field Measurements/Component Compliance									
Comp	liance Description	Data	Comp	liance	Description	Data			
N/A	Ramp Length (in)	59.0	No	Ramp	Slope (%)	10.2			
No	Ramp Width (in)	43.5	Yes	Ramp	XSlope (%)	1.6			
N/A	Flare Type LT	N/A	N/A	N/A Flare Type RT		N/A			
N/A	Flare Slope LT (%)	N/A	N/A	N/A Flare Slope RT (%)		N/A			
N/A	Flare Traversable LT?	N/A	N/A	Flare	Traversable RT?	N/A			
N/A	Landing Length (in)	N/A	N/A	DWS	Provided?	N/A			
N/A	Landing Width (in)	N/A	N/A	DWS	Contrast?	N/A			
N/A	Landing Slope (%)	N/A	N/A	DWS	Length (in)	N/A			
N/A	Landing X Slope (%)	N/A	N/A	DWS	Full Width?	N/A			
N/A	Landing Curb? (Y/N)	N/A	N/A	DWS	Offset (in)	N/A			
N/A	Shared Landing?	N/A							
N/A	Gutter Ponding?	N/A	N/A	Gutte	r Slope (%)	N/A			
N/A	Gutter Lip Ht (in)	N/A	N/A	Gutte	r X Slope (%)	N/A			
N/A	Painted X Walk1?	Yes	N/A	Paint	ed X Walk2?	N/A			
	X Walk 1 Direction	To NW		X Wa	lk 2 Direction	N/A			
N/A	X Walk 1 Width (in)	103.0	N/A	X Wa	lk 2 Width (in)	N/A

X Walk 1 Slope (%)	4.7		X Wa	lk 2 Slope (%)	N/A			
	X Walk 1 X Slope (%)	1.9		X Wa	lk 2 X Slope (%)	N/A			
N/A	Ramp inside XWalk1?	Yes	N/A	Ram	inside XWalk2?	N/A			
	Road Slope (%)	N/A	N/A	Clear	Space?	N/A			
	Road X Slope (%)	N/A	N/A	Clear	Space to XWalk (in)	N/A			
N/A	Any Obstructions?	N/A	N/A	Storn	n Grate/Utility Hazard?	N/A			
	Obstruction Type			Storn	n Grate/Utility Type				
		N/A				N/A			
			Yes	Surfa	ce Condition? (G/P)	Good

Possible Solutions:						
Remove & Replace Entire Ramp.						
·						
Surveyor Notes:						
N/A						
PROW/ADA:						
Not Found, R304.5.1, R304.2.2

1850.00
