## Access Compliance Report Public Rights-of-Way (Curb Ramps)

Intersection ID: 22944 Main Street: MOORLAND\_DR Cross Street: STONIER\_CT Location: N

ADA ID: 4124FCD98A10 Ramp Type: PerpDiag Initial Pass/Fail: Fail Overall Compliance: No Severity Score: 10

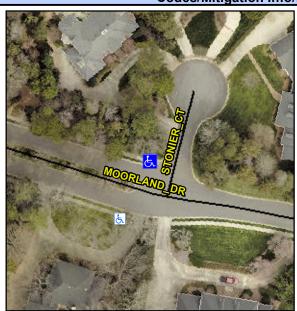
Not Found, R304.5.1, R304.5.3

| Field Measurements/Component Compilance | | | | | | |
|---|---|---|---|---|---|---|
| | N/A | Ramp Length (in) | 56.0 | Yes | Ramp Slope (%) | 6.7 |
| | No | Ramp Width (in) | 47.5 | No | Ramp XSlope (%) | 3.8 |

Remove & Replace Curb Ramp With
Two New Directional Ramps or
Equivalent.
