Access Compliance Report Public Rights-of-Way (Curb Ramps)

Intersection ID: N/A Main Street: SPEER_BV Cross Street: NATIONAL_AV Location: NW **Overall Compliance: No** Severity Score: 33.75 ADA ID: 4127263BDEA7 Ramp Type: Perp Initial Pass/Fail: Fail

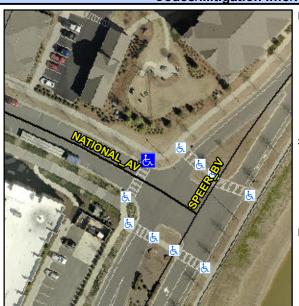
Field Measurements/Component Compliance						
Comp	liance Description	Data	Comp	liance	Description	Data
N/A	Ramp Length (in)	98.0	No	Ramp	Slope (%)	8.5
No	Ramp Width (in)	47.5	No	Ramp	XSlope (%)	5.3
N/A	Flare Type LT	N/A	N/A Flare Type RT		Type RT	N/A
N/A	Flare Slope LT (%)	N/A	N/A	N/A Flare Slope RT (%)		N/A
N/A	Flare Traversable LT?	N/A	N/A	A Flare Traversable RT?		N/A
N/A	Landing Length (in)	N/A	N/A	DWS	Provided?	N/A
N/A	Landing Width (in)	N/A	N/A	DWS	Contrast?	N/A
N/A	Landing Slope (%)	N/A	N/A	DWS	Length (in)	N/A
N/A	Landing X Slope (%)	N/A	N/A	DWS	Full Width?	N/A
N/A	Landing Curb? (Y/N)	N/A	N/A	DWS	Offset (in)	N/A
N/A	Shared Landing?	N/A				
N/A	Gutter Ponding?	N/A	N/A	Gutte	r Slope (%)	N/A
N/A	Gutter Lip Ht (in)	N/A	N/A	Gutte	r X Slope (%)	N/A
N/A	Painted X Walk1?	Yes	N/A	Paint	ed X Walk2?	N/A
	X Walk 1 Direction	To SW		X Wa	lk 2 Direction	N/A
N/A	X Walk 1 Width (in)	112.0	N/A	X Wa	lk 2 Width (in)	N/A

X Walk 1 Slope (%)	1.8		X Wa	lk 2 Slope (%)	N/A
	X Walk 1 X Slope (%)	5.5		X Wa	lk 2 X Slope (%)	N/A
N/A	Ramp inside XWalk1?	Yes	N/A	Ram	inside XWalk2?	N/A
	Road Slope (%)	N/A	N/A	Clear	Space?	N/A
	Road X Slope (%)	N/A	N/A	Clear	Space to XWalk (in)	N/A
N/A	Any Obstructions?	N/A	N/A	Storn	n Grate/Utility Hazard?	N/A
	Obstruction Type			Storn	n Grate/Utility Type	
		N/A				N/A
			Yes	Surfa	ce Condition? (G/P)	Good
	St. Becker

ossible Solution
Possible Solutions:
Remove & Replace Entire Ramp.
2 N.
Surveyor Notes:
N/A
PROW/ADA:
R304.5.1, R304.2.2, R304.5.3
