# Access Compliance Report

## Public Rights-of-Way

### (Curb Ramps)

Intersection ID: 6634	Main Street: ABERGLEN_DR	Cross Street: DOVERHILL_PL	Location: SE
ADA ID: 412D5B06B9F0	Ramp Type: PerpDiag	Initial Pass/Fail: Fail	Overall Compliance: No
Severity Score: 8.75			
Codes/Mitigation Info/Possible Solution		Field Measurements/Component Compliance

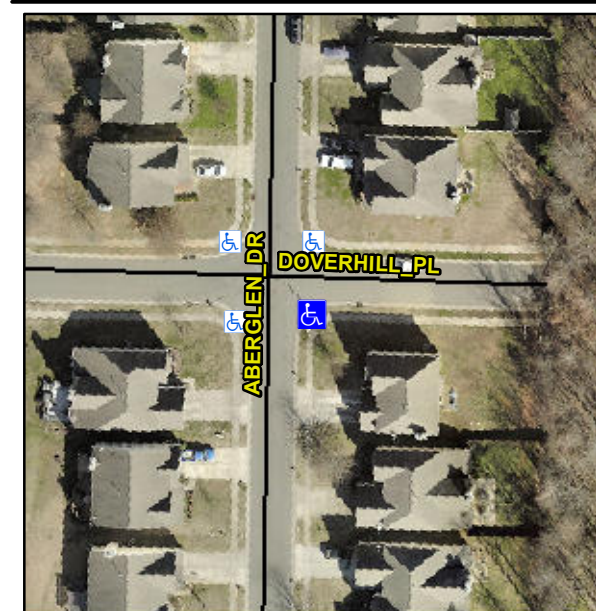
**Not Found, R304.5.1**

Compliance	Description	Data	Compliance	Description	Data
N/A	Ramp Length (in)	48.0	Yes	Ramp Slope (%)	5.8
No	Ramp Width (in)	43.5	Yes	Ramp XSlope (%)	0.0
N/A	Flare Type LT	N/A	N/A	Flare Type RT	N/A
N/A	Flare Slope LT (%)	N/A	N/A	Flare Slope RT (%)	N/A
N/A	Flare Traversable LT?	N/A	N/A	Flare Traversable RT?	N/A
N/A	Landing Length (in)	N/A	N/A	DWS Provided?	N/A
N/A	Landing Width (in)	N/A	N/A	DWS Contrast?	N/A
N/A	Landing Slope (%)	N/A	N/A	DWS Length (in)	N/A
N/A	Landing X Slope (%)	N/A	N/A	DWS Full Width?	N/A
N/A	Landing Curb? (Y/N)	N/A	N/A	DWS Offset (in)	N/A
N/A	Shared Landing?	N/A			
N/A	Gutter Ponding?	N/A	N/A	Gutter Slope (%)	N/A
N/A	Gutter Lip Ht (in)	N/A	N/A	Gutter X Slope (%)	N/A
N/A	Painted X Walk1?	No	N/A	Painted X Walk2?	No
	X Walk 1 Direction	To NE		X Walk 2 Direction	To W
N/A	X Walk 1 Width (in)	N/A	N/A	X Walk 2 Width (in)	N/A
	X Walk 1 Slope (%)	2.6		X Walk 2 Slope (%)	0.1
	X Walk 1 X Slope (%)	1.4		X Walk 2 X Slope (%)	3.2

N/A	Ramp inside XWalk1?	N/A	N/A	Ramp inside XWalk2?	N/A
	Road Slope (%)	0.3	N/A	Clear Space?	N/A
	Road X Slope (%)	2.8	N/A	Clear Space to XWalk (in)	N/A
N/A	Any Obstructions?	N/A	N/A	Storm Grate/Utility Hazard?	N/A
	Obstruction Type			Storm Grate/Utility Type	
		N/A			N/A
		Yes		Surface Condition? (G/P)	Good

**Remove & Replace Curb Ramp With Two New Directional Ramps or Equivalent.**
