Access Compliance Report

Public Rights-of-Way

(Curb Ramps)

Intersection ID: 5212	Main Street: BELLHAVEN_BV	Cross Street: CAMERON_SPRING_RD	Location: SW
ADA ID: 413945D70B00	Ramp Type: Perp	Initial Pass/Fail: Fail	Overall Compliance: No
Codes/Mitigation Info/Possible Solution			Severity Score: 25
			Field Measurements/Component Compliance

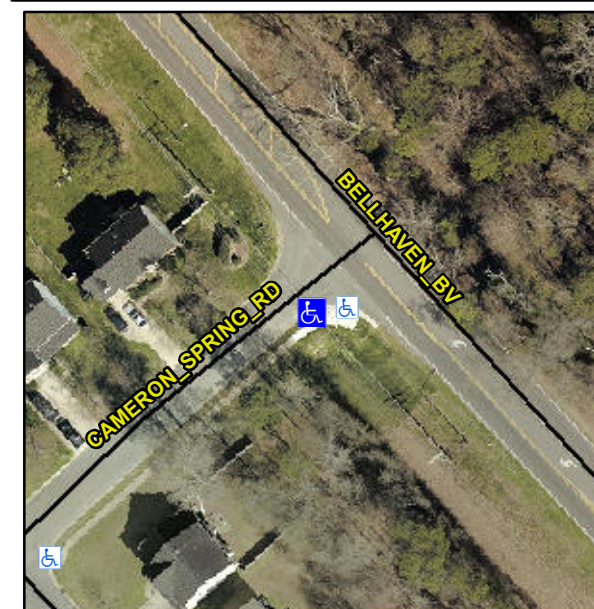
Not Found, R304.2.2, R304.5.3

Compliance	Description	Data	Compliance	Description	Data
N/A	Ramp Length (in)	48.0	No	Ramp Slope (%)	11.0
Yes	Ramp Width (in)	52.0	No	Ramp XSlope (%)	6.0
N/A	Flare Type LT	N/A	N/A	Flare Type RT	N/A
N/A	Flare Slope LT (%)	N/A	N/A	Flare Slope RT (%)	N/A
N/A	Flare Traversable LT?	N/A	N/A	Flare Traversable RT?	N/A
N/A	Landing Length (in)	N/A	N/A	DWS Provided?	N/A
N/A	Landing Width (in)	N/A	N/A	DWS Contrast?	N/A
N/A	Landing Slope (%)	N/A	N/A	DWS Length (in)	N/A
N/A	Landing X Slope (%)	N/A	N/A	DWS Full Width?	N/A
N/A	Landing Curb? (Y/N)	N/A	N/A	DWS Offset (in)	N/A
N/A	Shared Landing?	N/A			
N/A	Gutter Ponding?	N/A	N/A	Gutter Slope (%)	N/A
N/A	Gutter Lip Ht (in)	N/A	N/A	Gutter X Slope (%)	N/A
N/A	Painted X Walk1?	No	N/A	Painted X Walk2?	N/A
	X Walk 1 Direction	To NE		X Walk 2 Direction	N/A
N/A	X Walk 1 Width (in)	N/A	N/A	X Walk 2 Width (in)	N/A
	X Walk 1 Slope (%)	3.6		X Walk 2 Slope (%)	N/A
	X Walk 1 X Slope (%)	4.8		X Walk 2 X Slope (%)	N/A

N/A	Ramp inside XWalk1?	N/A	N/A	Ramp inside XWalk2?	N/A
	Road Slope (%)	4.8	N/A	Clear Space?	N/A
	Road X Slope (%)	3.6	N/A	Clear Space to XWalk (in)	N/A
N/A	Any Obstructions?	N/A	N/A	Storm Grate/Utility Hazard?	N/A
	Obstruction Type			Storm Grate/Utility Type	
		N/A			N/A
			Yes	Surface Condition? (G/P)	Good

Remove & Replace Entire Ramp.
