Access Compliance Report

Public Rights-of-Way

(Curb Ramps)

Intersection ID: 24195	Main Street: PROVIDENCE_RD	Cross Street: BEVERLY_CREST_BV	Location: SW
ADA ID: 414BEDB157CF	Ramp Type: PerpDiag	Initial Pass/Fail: Fail	Overall Compliance: No
		Severity Score: 22.5

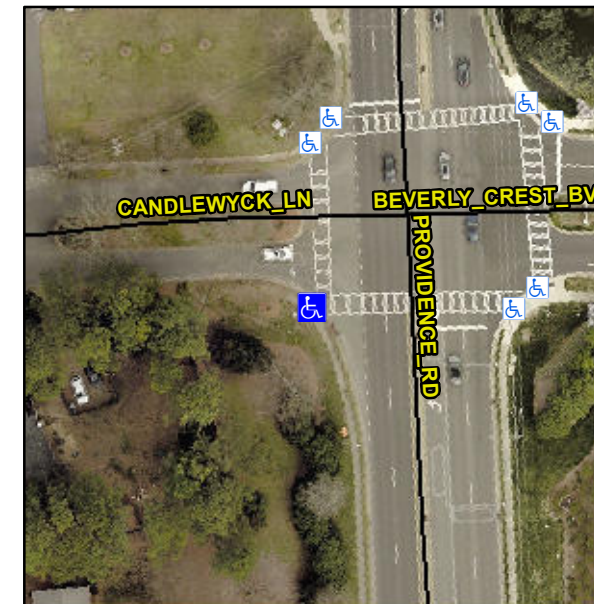
Compliance	Description	Data	Compliance	Description	Data
N/A	Ramp Length (in)	72.0	No	Ramp Slope (%)	10.3
No	Ramp Width (in)	46.0	No	Ramp XSlope (%)	2.4
N/A	Flare Type LT	N/A	N/A	Flare Type RT	N/A
N/A	Flare Slope LT (%)	N/A	N/A	Flare Slope RT (%)	N/A
N/A	Flare Traversable LT?	N/A	N/A	Flare Traversable RT?	N/A
N/A	Landing Length (in)	N/A	N/A	DWS Provided?	N/A
N/A	Landing Width (in)	N/A	N/A	DWS Contrast?	N/A
N/A	Landing Slope (%)	N/A	N/A	DWS Length (in)	N/A
N/A	Landing X Slope (%)	N/A	N/A	DWS Full Width?	N/A
N/A	Landing Curb? (Y/N)	N/A	N/A	DWS Offset (in)	N/A
N/A	Shared Landing?	N/A			
N/A	Gutter Ponding?	Yes	N/A	Gutter Slope (%)	N/A
N/A	Gutter Lip Ht (in)	N/A	N/A	Gutter X Slope (%)	N/A
N/A	Painted X Walk1?	No	N/A	Painted X Walk2?	No
	X Walk 1 Direction	To E		X Walk 2 Direction	To N
N/A	X Walk 1 Width (in)	N/A	N/A	X Walk 2 Width (in)	N/A
	X Walk 1 Slope (%)	0.5		X Walk 2 Slope (%)	0.3
	X Walk 1 X Slope (%)	0.2		X Walk 2 X Slope (%)	1.6

N/A	Ramp inside XWalk1?	N/A	N/A	Ramp inside XWalk2?	N/A
	Road Slope (%)	0.1	N/A	Clear Space?	N/A
	Road X Slope (%)	3.7	N/A	Clear Space to XWalk (in)	N/A
N/A	Any Obstructions?	N/A	N/A	Storm Grate/Utility Hazard?	N/A
	Obstruction Type			Storm Grate/Utility Type	
		N/A			N/A
		Yes		Surface Condition? (G/P)	Good

Remove & Replace Curb Ramp With Two New Directional Ramps or Equivalent.
