Intersection ID: N/A	Main Street: MARKLAND_DR	Cross Street: FORDWOOD_DR	Location:	NE
ADA ID: 415ADAE50990	Ramp Type: PerpDiag	Initial Pass/Fail: Fail	Overall Compliance: No	Severity Score: 8.75

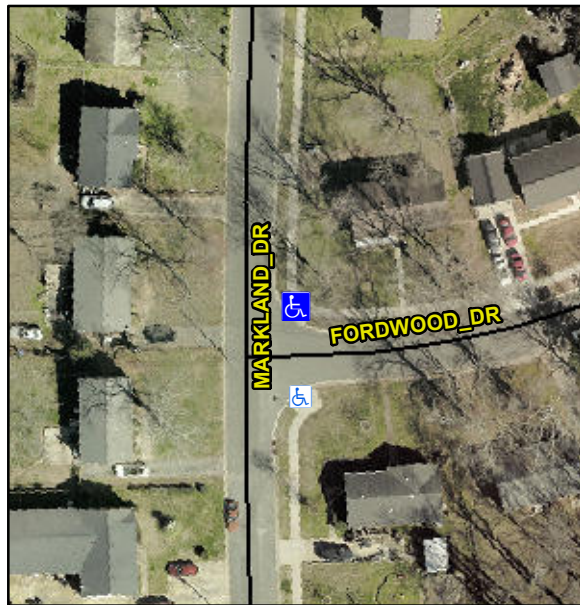
Compliance	Description	Data	Compliance	Description	Data
N/A	Ramp Length (in)	71.0	Yes	Ramp Slope (%)	5.4
No	Ramp Width (in)	47.0	Yes	Ramp XSlope (%)	1.1
N/A	Flare Type LT	N/A	N/A	Flare Type RT	N/A
N/A	Flare Slope LT (%)	N/A	N/A	Flare Slope RT (%)	N/A
N/A	Flare Traversable LT?	N/A	N/A	Flare Traversable RT?	N/A
N/A	Landing Length (in)	N/A	N/A	DWS Provided?	N/A
N/A	Landing Width (in)	N/A	N/A	DWS Contrast?	N/A
N/A	Landing Slope (%)	N/A	N/A	DWS Length (in)	N/A
N/A	Landing X Slope (%)	N/A	N/A	DWS Full Width?	N/A
N/A	Landing Curb? (Y/N)	N/A	N/A	DWS Offset (in)	N/A
N/A	Shared Landing?	N/A			
N/A	Gutter Ponding?	N/A	N/A	Gutter Slope (%)	N/A
N/A	Gutter Lip Ht (in)	N/A	N/A	Gutter X Slope (%)	N/A
N/A	Painted X Walk1?	No	N/A	Painted X Walk2?	No
	X Walk 1 Direction	To W		X Walk 2 Direction	To S
N/A	X Walk 1 Width (in)	N/A	N/A	X Walk 2 Width (in)	N/A
	X Walk 1 Slope (%)	3.1		X Walk 2 Slope (%)	7.4
	X Walk 1 X Slope (%)	7.4		X Walk 2 X Slope (%)	1.7

N/A	Ramp inside XWalk1?	N/A	N/A	Ramp inside XWalk2?	N/A
	Road Slope (%)	5.2	N/A	Clear Space?	N/A
	Road X Slope (%)	9.9	N/A	Clear Space to XWalk (in)	N/A
N/A	Any Obstructions?	N/A	N/A	Storm Grate/Utility Hazard?	N/A
	Obstruction Type			Storm Grate/Utility Type	
		N/A			N/A
			Yes	Surface Condition? (G/P)	Good

Remove & Replace Curb Ramp With Two New Directional Ramps or Equivalent.
