## **Access Compliance Report Public Rights-of-Way** (Curb Ramps)

Main Street: BALLANTYNE\_COMMONS\_PY Cross Street: ESSEX\_FELLS\_DR Intersection ID: 27277 Location: NW **Overall Compliance: No Severity Score:** 22.5 ADA ID: 415AE5EA4D9F Ramp Type: PerpDiag Initial Pass/Fail: Fail

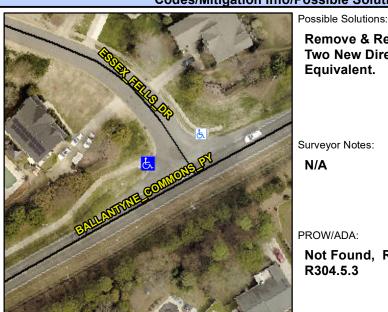
Not Found, R304.5.1, R304.2.2, R304.5.3

Compliance Description Data Compliance Description No N/A Ramp Length (in) 62.0 Ramp Slope (%) No Ramp XSlope (%) No Ramp Width (in) 46.0 N/A N/A Flare Type LT N/A Flare Type RT N/A N/A N/A Flare Slope RT (%) Flare Slope LT (%) N/A Flare Traversable LT? N/A N/A Flare Traversable RT? N/A N/A N/A DWS Provided? Landing Length (in) N/A Landing Width (in) N/A N/A **DWS Contrast?** N/A N/A N/A Landing Slope (%) DWS Length (in) N/A Landing X Slope (%) N/A N/A DWS Full Width? N/A Landing Curb? (Y/N) N/A N/A DWS Offset (in) N/A N/A Shared Landing? N/A **Gutter Ponding?** N/A N/A Gutter Slope (%) N/A Gutter Lip Ht (in) N/A N/A Gutter X Slope (%) N/A Painted X Walk1? No N/A Painted X Walk2? X Walk 1 Direction To S X Walk 2 Direction N/A N/A X Walk 2 Width (in) X Walk 1 Width (in) X Walk 1 Slope (%) 2.8 X Walk 2 Slope (%) X Walk 1 X Slope (%) 1.9 X Walk 2 X Slope (%) N/A N/A N/A Ramp inside XWalk2? Ramp inside XWalk1? Road Slope (%) 0.8 N/A Clear Space? N/A Road X Slope (%) 0.8 Clear Space to XWalk (in) N/A N/A N/A Any Obstructions? Storm Grate/Utility Hazard? **Obstruction Type** Storm Grate/Utility Type

Remove & Replace Curb Ramp With Two New Directional Ramps or Equivalent.
