Access Compliance Report

Public Rights-of-Way

(Curb Ramps)

Intersection ID: 18958	Main Street: GROVER_RD	Cross Street: OLD_PINEVILLE_RD	Location: SW
ADA ID: 4162C5473EE0	Ramp Type: Para	Initial Pass/Fail: Pass	Overall Compliance: No
		Severity Score: 0

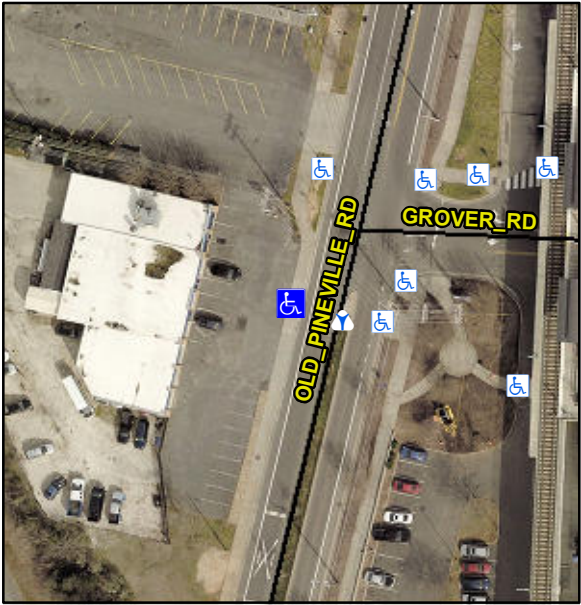
Compliance	Description	Data	Compliance	Description	Data
N/A	Ramp Length LT (in)	70.5	N/A	Ramp Length RT (in)	73.0
Yes	Ramp Width LT (in)	72.0	Yes	Ramp Width RT (in)	72.0
Yes	Ramp Slope LT (%)	7.5	Yes	Ramp Slope RT (%)	5.6
Yes	Ramp XSlope LT (%)	0.7	Yes	Ramp XSlope RT (%)	1.1
Yes	Landing Length (in)	72.0	Yes	DWS Provided?	Yes
Yes	Landing Width (in)	48.0	Yes	DWS Contrast?	Yes
No	Landing Slope (%)	2.1	Yes	DWS Length (in)	24.0
Yes	Landing X Slope (%)	0.4	Yes	DWS Full Width?	Yes
N/A	Landing Curb? (Y/N)	No	No	DWS Offset (in)	3.5
N/A	Shared Landing?	No			
Yes	Gutter Ponding?	No	Yes	Gutter Slope (%)	0.8
Yes	Gutter Lip Ht (in)	0.0	Yes	Gutter X Slope (%)	1.2
N/A	Painted X Walk1?	No	N/A	Painted X Walk2?	N/A
	X Walk 1 Direction	To E		X Walk 2 Direction	N/A
N/A	X Walk 1 Width (in)	N/A	N/A	X Walk 2 Width (in)	N/A
	X Walk 1 Slope (%)	2.8		X Walk 2 Slope (%)	N/A
	X Walk 1 X Slope (%)	0.9		X Walk 2 X Slope (%)	N/A
N/A	Ramp inside XWalk1?	N/A	N/A	Ramp inside XWalk2?	N/A

Road Slope (%)	N/A	N/A	Clear Space?	Yes
	Road X Slope (%)	N/A	N/A	Clear Space to XWalk (in)	N/A
Yes	Any Obstructions?	No	Yes	Storm Grate/Utility Hazard?	No
	Obstruction Type			Storm Grate/Utility Type	
		N/A			N/A
			Yes	Surface Condition? (G/P)	Good
			Replace	Curb Slope (%)	17.4

Possible Solutions:				
	Remove & Replace Entire Ramp.				
	Surveyor Notes:				
	N/A				
	PROW/ADA:				
	Not Found, R304.2.2-Perp, R304.3.2-Para, R305.2				
Street 1 Name	OLD PINEVILLE RD				
Stop Condition-Street 1	None				
Street 2 Name	N/A				
Stop Condition-Street 2	N/A				
Total Cost:		\$	1600.00
