## **Access Compliance Report Public Rights-of-Way** (Curb Ramps)

Intersection ID: 22285 Main Street: QUAIL HOLLOW RD **Cross Street: HAMPTONRIDGE DR** Location: SE ADA ID: 416963B1A1CD Ramp Type: PerpDiag Initial Pass/Fail: Fail **Overall Compliance: No** Severity Score: 26.25

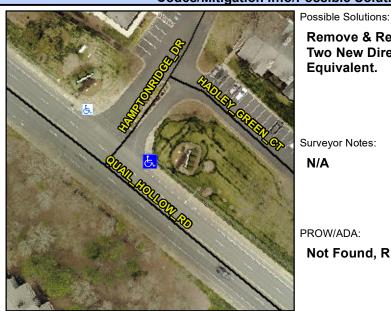
Not Found, R304.2.2, R304.5.3

Compliance Description		Data	Comp	liance	Description	Data	
N/A	N/A Ramp Length (in)		63.0	No	Ram	Slope (%)	14.3
Yes	Ramp	o Width (in)	48.0	No	Ram	XSlope (%)	4.7
N/A	Flare	Type LT	N/A	N/A	Flare	Type RT	N/A
N/A	Flare	Slope LT (%)	N/A	N/A	Flare	Slope RT (%)	N/A
N/A	Flare	Traversable LT?	N/A	N/A	Flare	Traversable RT?	N/A
N/A	Landi	ing Length (in)	N/A	N/A	DWS	Provided?	N/A
N/A	Landi	ing Width (in)	N/A	N/A	DWS	Contrast?	N/A
N/A	Landi	ing Slope (%)	N/A	N/A	DWS	Length (in)	N/A
N/A	Landi	ing X Slope (%)	N/A	N/A	DWS	Full Width?	N/A
N/A	Landi	ing Curb? (Y/N)	N/A	N/A	DWS	Offset (in)	N/A
N/A	Share	ed Landing?	N/A				
N/A	Gutte	er Ponding?	N/A	N/A	Gutte	er Slope (%)	N/A
N/A	Gutte	er Lip Ht (in)	N/A	N/A	Gutte	er X Slope (%)	N/A
N/A	Paint	ed X Walk1?	No	N/A	Paint	ed X Walk2?	No
	X Wa	lk 1 Direction	To NW		X Wa	lk 2 Direction	To SW
N/A	X Wa	lk 1 Width (in)	N/A	N/A	X Wa	lk 2 Width (in)	N/A
	X Wa	lk 1 Slope (%)	1.0		X Wa	lk 2 Slope (%)	0.8

X Wa	lk 1 X Slope (%)	4.8		X Wa	lk 2 X Slope (%)	2.4
N/A	Ramp	inside XWalk1?	N/A	N/A	Ram	o inside XWalk2?	N/A
	Road	Slope (%)	2.0	N/A	Clear	Space?	N/A
	Road	X Slope (%)	2.8	N/A	Clear	Space to XWalk (in)	N/A
N/A	Any (	Obstructions?	N/A	N/A	Storn	n Grate/Utility Hazard?	N/A
	Obstr	ruction Type			Storn	n Grate/Utility Type	
			N/A				N/A

Street 1 Name Stop Condition-Street 2 Street 2 Name Stop Condition-Street 1 HAMPTONBRIDGE DR None **QUAIL HOLLOW RD** None Remove & Replace Curb Ramp With Two New Directional Ramps or Equivalent.
