Access Compliance Report

Public Rights-of-Way

(Curb Ramps)

Intersection ID: 14311	Main Street: BERKELEY_AV	Cross Street: CARLTON_AV	Location: S
ADA ID: 416C41A17F43	Ramp Type: BlendTrans2	Initial Pass/Fail: Fail	Overall Compliance: No
		Severity Score: 12.5

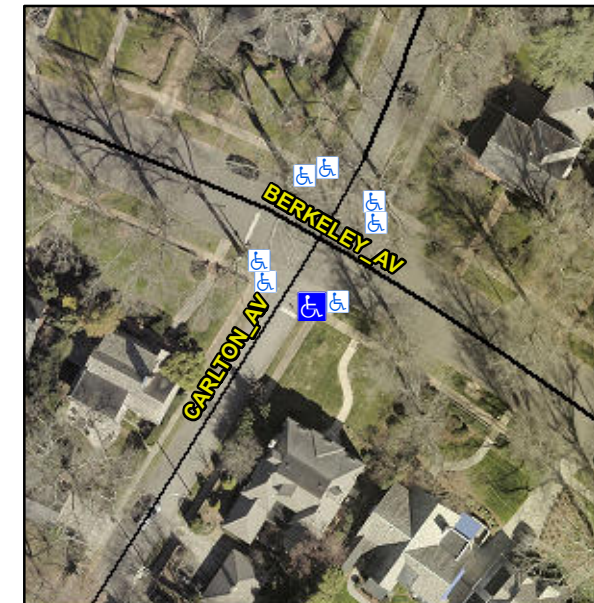
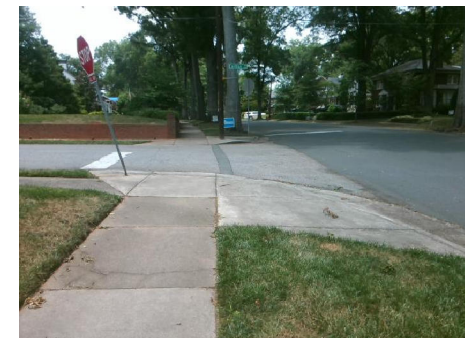
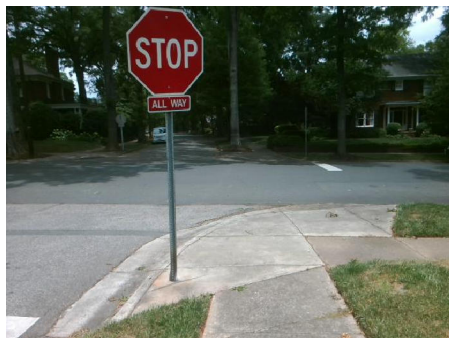
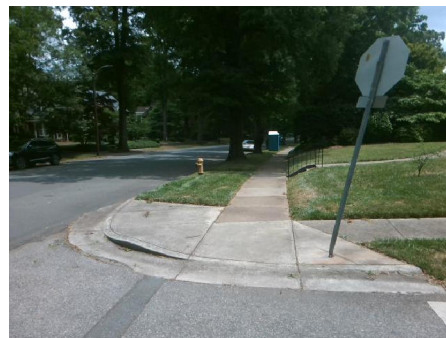
Compliance	Description	Data	Compliance	Description	Data
N/A	Ramp Length (in)	70.0	Yes	BlendTrans Slope (%)	0.1
Yes	Ramp Width (in)	59.5	No	BlendTrans XSlope (%)	6.3
N/A	Flare Type LT	N/A	N/A	Flare Type RT	N/A
N/A	Flare Slope LT (%)	N/A	N/A	Flare Slope RT (%)	N/A
N/A	Flare Traversable LT?	N/A	N/A	Flare Traversable RT?	N/A
N/A	Landing Length (in)	N/A	N/A	DWS Provided?	N/A
N/A	Landing Width (in)	N/A	N/A	DWS Contrast?	N/A
N/A	Landing Slope (%)	N/A	N/A	DWS Length (in)	N/A
N/A	Landing X Slope (%)	N/A	N/A	DWS Full Width?	N/A
N/A	Landing Curb? (Y/N)	N/A	N/A	DWS Offset (in)	N/A
N/A	Shared Landing?	N/A			
N/A	Gutter Ponding?	N/A	N/A	Gutter Slope (%)	N/A
N/A	Gutter Lip Ht (in)	1.0	N/A	Gutter X Slope (%)	N/A
N/A	Painted X Walk1?	No	N/A	Painted X Walk2?	N/A
	X Walk 1 Direction	To NW		X Walk 2 Direction	N/A
	X Walk 1 Width (in)	N/A		X Walk 2 Width (in)	N/A
	X Walk 1 Slope (%)	5.5		X Walk 2 Slope (%)	N/A
	X Walk 1 X Slope (%)	2.8		X Walk 2 X Slope (%)	N/A

N/A	Ramp inside XWalk1?	N/A	N/A	Ramp inside XWalk2?	N/A
	Road Slope (%)	2.8		Clear Space?	N/A
	Road X Slope (%)	5.5	N/A	Clear Space to XWalk (in)	N/A
N/A	Any Obstructions?	N/A	N/A	Storm Grate/Utility Hazard?	N/A
	Obstruction Type			Storm Grate/Utility Type	
		N/A			N/A
			Yes	Surface Condition? (G/P)	Good
			N/A	Curb Slope (%)	3.3

Remove & Replace Curb Ramp With Two New Directional Ramps or Equivalent.

R304.5.3
