# Access Compliance Report

## Public Rights-of-Way (Curb Ramps)

| Intersection ID: 27595 | Main Street: BALLANTYNE COMMONS PY | Cross Street: BALLANTYNE MEADOWS DR | Location: NE |
| ADA ID: 416E348E346D | Ramp Type: Perp | Initial Pass/Fail: Fail | Overall Compliance: No |

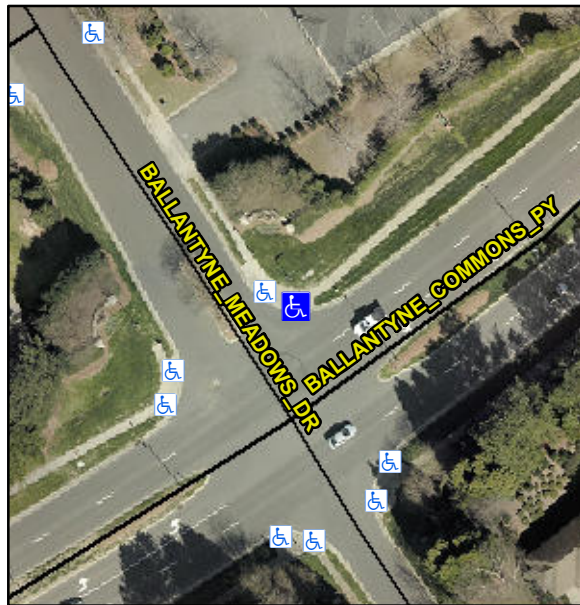
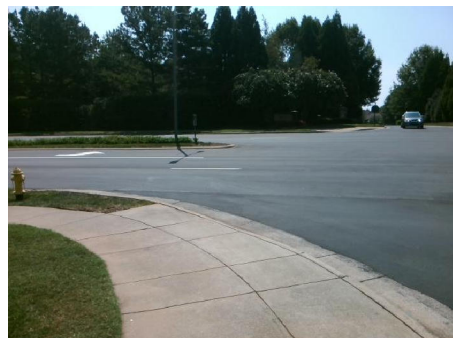
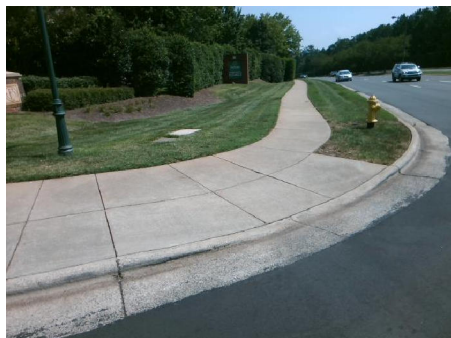
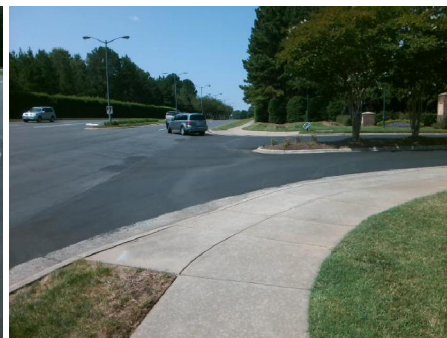
**Not Found, R304.5.1**

| Compliance | Description | Data | Compliance | Description | Data |
|---|---|---|---|---|---|
| No | Ramp Width (in) | 38.0 | Yes | Ramp XSlope (%) | 2.9 |

**Remove & Replace Entire Ramp.**
