# Access Compliance Report

## Public Rights-of-Way

| Intersection ID: 32292 | Main Street: OLD_ARDREY_KELL_RD | Cross Street: HONEYNUT_DR | Location: SW |
| ADA ID: 418207A5B221 | Ramp Type: Combination1Diag | Initial Pass/Fail: Fail | Overall Compliance: No |

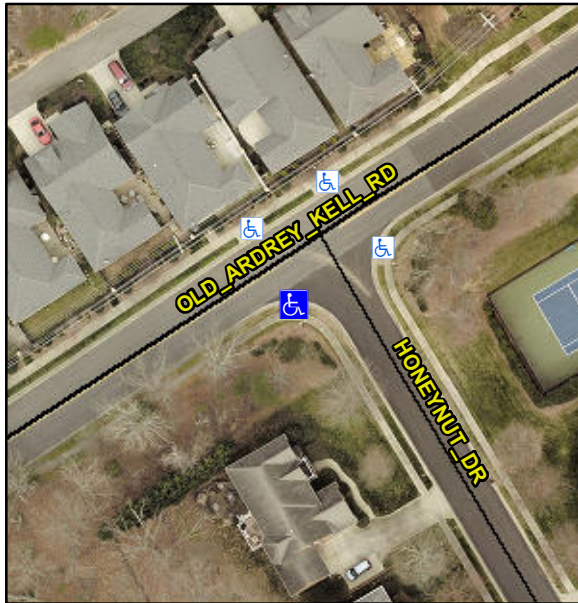
**CURB LIP 0.5**

**R304.5.3**

| Compliance | Description | Data | Compliance | Description | Data |
|---|---|---|---|---|---|
| Yes | Ramp Width (in) | 48.0 | No | Ramp XSlope (%) | 6.3 |

**Remove & Replace Curb Ramp With Two New Directional Ramps or Equivalent.**
