# Access Compliance Report

## Public Rights-of-Way

### (Curb Ramps)

| Intersection ID: 47852 | Main Street: CACTUS_VALLEY_RD | Cross Street: STONE_PORCH_RD | Location: NW |

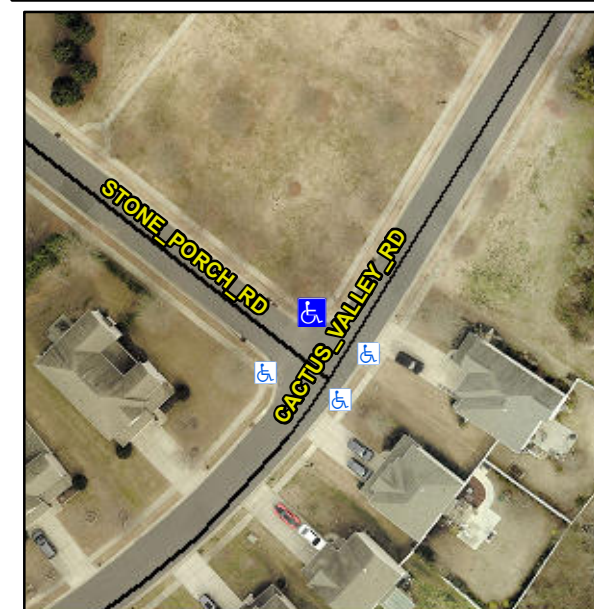
| ADA ID: 41854EB5EC10 | Ramp Type: BlendTrans2 | Initial Pass/Fail: Fail | Overall Compliance: No |
| Severity Score: 8.75 | | | |

**Not Found, R304.5.1**

| Compliance | Description | Data | Compliance | Description | Data |
|---|---|---|---|---|---|
| No | Ramp Width (in) | 47.0 | Yes | BlendTrans XSlope (%) | 1.2 |
| | | | No | Curb Slope (%) | 22.1 |

**Remove & Replace Curb Ramp With Two New Directional Ramps or Equivalent.**

Total Cost: \$ 3200.00
