Access Compliance Report

Public Rights-of-Way

(Curb Ramps)

Intersection ID: N/A	Main Street: STEEL_CREEK_RD	Cross Street: SNOW_RIDGE_LN	Location: NW
ADA ID: 4193B5E08C30	Ramp Type: PerpDiag	Initial Pass/Fail: Fail	Overall Compliance: No
		Severity Score: 10

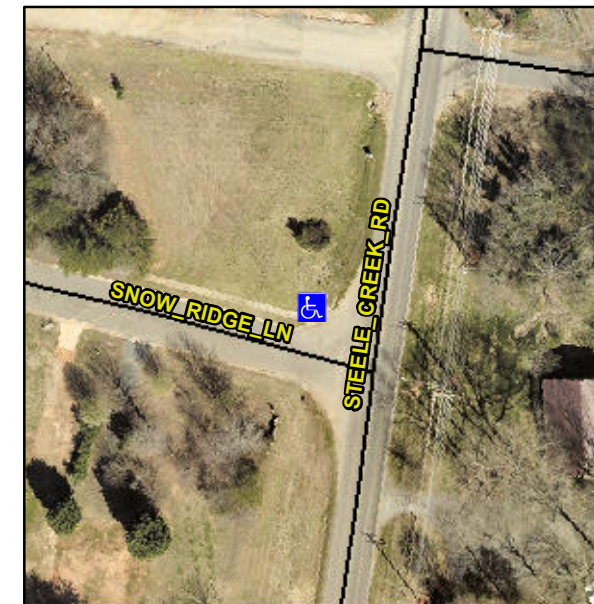
Not Found, R304.5.1, R304.5.3

Compliance	Description	Data	Compliance	Description	Data
N/A	Ramp Length (in)	48.0	Yes	Ramp Slope (%)	7.7
No	Ramp Width (in)	44.0	No	Ramp XSlope (%)	2.7
N/A	Flare Type LT	N/A	N/A	Flare Type RT	N/A
N/A	Flare Slope LT (%)	N/A	N/A	Flare Slope RT (%)	N/A
N/A	Flare Traversable LT?	N/A	N/A	Flare Traversable RT?	N/A
N/A	Landing Length (in)	N/A	N/A	DWS Provided?	N/A
N/A	Landing Width (in)	N/A	N/A	DWS Contrast?	N/A
N/A	Landing Slope (%)	N/A	N/A	DWS Length (in)	N/A
N/A	Landing X Slope (%)	N/A	N/A	DWS Full Width?	N/A
N/A	Landing Curb? (Y/N)	N/A	N/A	DWS Offset (in)	N/A
N/A	Shared Landing?	N/A			
N/A	Gutter Ponding?	N/A	N/A	Gutter Slope (%)	N/A
N/A	Gutter Lip Ht (in)	N/A	N/A	Gutter X Slope (%)	N/A
N/A	Painted X Walk1?	No	N/A	Painted X Walk2?	No
	X Walk 1 Direction	To S		X Walk 2 Direction	To E
N/A	X Walk 1 Width (in)	N/A	N/A	X Walk 2 Width (in)	N/A
	X Walk 1 Slope (%)	3.0		X Walk 2 Slope (%)	1.8
	X Walk 1 X Slope (%)	1.3		X Walk 2 X Slope (%)	1.2

Remove & Replace Curb Ramp With Two New Directional Ramps or Equivalent.
