Access Compliance Report

Public Rights-of-Way

(Curb Ramps)

Intersection ID: 24473	Main Street: CAMERON_WOOD_DR	Cross Street: DEER SPRING_LN	Location:	N
ADA ID: 4193F36BBE62	Ramp Type: PerpDiag	Initial Pass/Fail: Fail	Overall Compliance: No	Severity Score: 46.25
Codes/Mitigation Info/Possible Solution		Field Measurements/Component Compliance

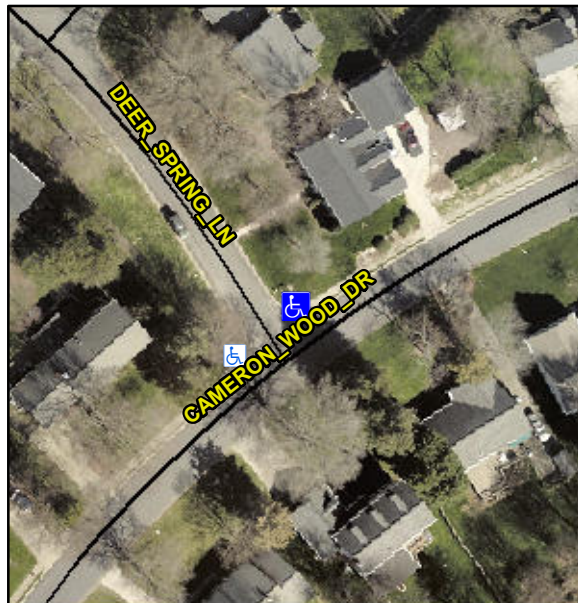
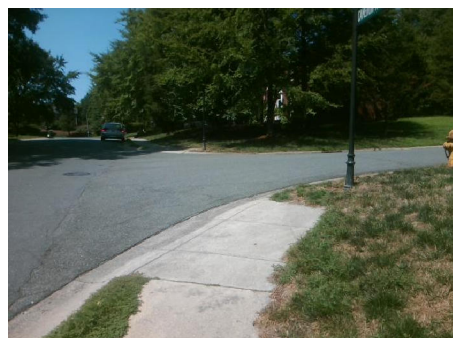
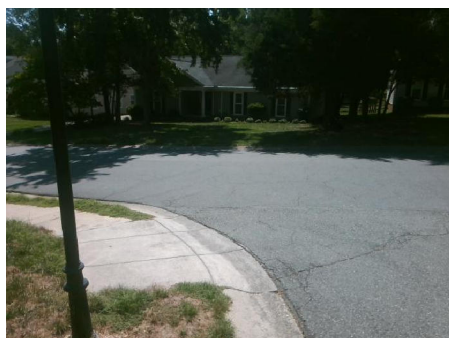
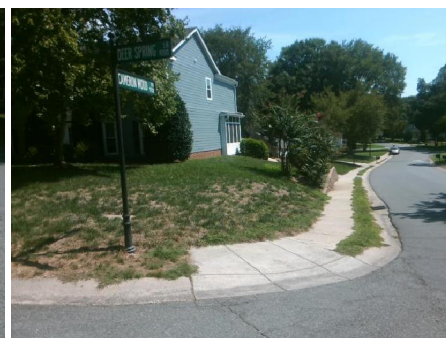
Not Found, R304.5.1, R304.2.2, R304.5.3

Compliance	Description	Data	Compliance	Description	Data
N/A	Ramp Length (in)	63.0	No	Ramp Slope (%)	8.6
No	Ramp Width (in)	39.0	No	Ramp XSlope (%)	14.7
N/A	Flare Type LT	N/A	N/A	Flare Type RT	N/A
N/A	Flare Slope LT (%)	N/A	N/A	Flare Slope RT (%)	N/A
N/A	Flare Traversable LT?	N/A	N/A	Flare Traversable RT?	N/A
N/A	Landing Length (in)	N/A	N/A	DWS Provided?	N/A
N/A	Landing Width (in)	N/A	N/A	DWS Contrast?	N/A
N/A	Landing Slope (%)	N/A	N/A	DWS Length (in)	N/A
N/A	Landing X Slope (%)	N/A	N/A	DWS Full Width?	N/A
N/A	Landing Curb? (Y/N)	N/A	N/A	DWS Offset (in)	N/A
N/A	Shared Landing?	N/A			
N/A	Gutter Ponding?	N/A	N/A	Gutter Slope (%)	N/A
N/A	Gutter Lip Ht (in)	N/A	N/A	Gutter X Slope (%)	N/A
N/A	Painted X Walk1?	No	N/A	Painted X Walk2?	No
	X Walk 1 Direction	To SW		X Walk 2 Direction	To S
N/A	X Walk 1 Width (in)	N/A	N/A	X Walk 2 Width (in)	N/A
	X Walk 1 Slope (%)	9.7		X Walk 2 Slope (%)	1.0
	X Walk 1 X Slope (%)	3.5		X Walk 2 X Slope (%)	12.4

N/A	Ramp inside XWalk1?	N/A	N/A	Ramp inside XWalk2?	N/A
	Road Slope (%)	14.0	N/A	Clear Space?	N/A
	Road X Slope (%)	8.3	N/A	Clear Space to XWalk (in)	N/A
N/A	Any Obstructions?	N/A	N/A	Storm Grate/Utility Hazard?	N/A
	Obstruction Type			Storm Grate/Utility Type	
		N/A			N/A
			Yes	Surface Condition? (G/P)	Good

Remove & Replace Curb Ramp With Two New Directional Ramps or Equivalent.
