Access Compliance Report

Public Rights-of-Way

(Curb Ramps)

Intersection ID: 51615		Main Street: BENFIELD_RD		Cross Street: PROSPERITY_CHURCH_RD		Location: SW											
ADA ID: 41A42AC769A6		Ramp Type: Directional1		Initial Pass/Fail: Pass		Overall Compliance: No		Severity Score: 0.25									
Codes/Mitigation Info/Possible Solution				Field Measurements/Component Compliance													
<div>

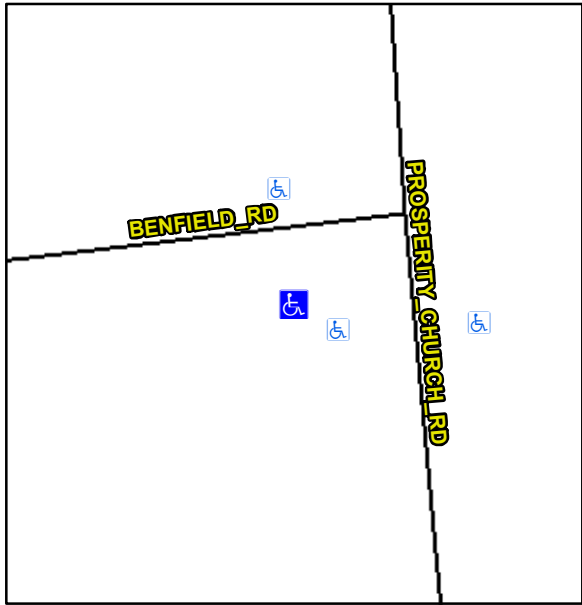
</div> <div>Possible Solutions: Remove & Replace Entire Ramp. Remove & Replace Gutter.</div> <div>Surveyor Notes: N/A</div> <div>PROW/ADA: R304.2.2-Perp, R304.3.2-Para, R304.5.3, R304.5.2, R305.2</div> <div>Street 1 Name BENFIELD RD</div> <div>Stop Condition-Street 1 Signal</div> <div>Street 2 Name N/A</div> <div>Stop Condition-Street 2 N/A</div> <div>Total Cost: \$ 2350.00</div>				Compliance		Description		Data		Compliance		Description		Data			
				N/A		Ramp Length (in)		93.0		No		Grade Break?		No			
				Yes		Ramp Width (in)		71.0		N/A		Grade Break Slope (%)		N/A

Yes		Ramp Slope (%)		6.7		N/A		Grade Break XSlope (%)		N/A			
				Yes		Ramp XSlope (%)		5.0									
				Yes		Flare Type LT		N/A		Yes		Flare Type RT		N/A			
				N/A		Flare Slope LT (%)		N/A		N/A		Flare Slope RT (%)		N/A			
				N/A		Flare Traversable LT?		No		N/A		Flare Traversable RT?		No			
				Yes		Landing Length (in)		72.0		Yes		DWS Provided?		Yes			
				Yes		Landing Width (in)		72.0		Yes		DWS Contrast?		Yes			
				No		Landing Slope (%)		3.0		Yes		DWS Length (in)		24.0			
				No		Landing X Slope (%)		7.0		Yes		DWS Full Width?		Yes			
				N/A		Landing Curb? (Y/N)		N/A		No		DWS Offset LT (in)		3.0			
				N/A		Shared Landing?		No		Yes		DWS Offset RT (in)		10.0			
				Yes		Gutter Ponding?		No		Yes		Gutter Slope (%)		3.2			
				Yes		Gutter Lip Ht (in)		0.0		No		Gutter X Slope (%)		6.2			
				N/A		Painted X Walk1?		Yes				Road Slope (%)		0.6			
						X Walk 1 Direction		To N				Road X Slope (%)		5.1

X Walk 1 Width (in)		111.0				Clear Space?		Yes			
						X Walk 1 Slope (%)		0.6		N/A		Clear Space to XWalk (in)		N/A			
						X Walk 1 X Slope (%)		5.1		Yes		Storm Grate/Utility Hazard?		No			
				Yes		Ramp inside XWalk1?		Yes				Storm Grate/Utility Type					
				Yes		Any Obstructions?		No						N/A			
						Obstruction Type				Yes		Surface Condition? (G/P)		Good			
										N/A		N/A		Curb Slope (%)		N/A
