Access Compliance Report

Public Rights-of-Way

(Curb Ramps)

Intersection ID: 45757	Main Street: MOSS_GLEN_CT	Cross Street: GRANDEUR_RD	Location: NE
ADA ID: 41ADFEFBBF46	Ramp Type: PerpDiag	Initial Pass/Fail: Fail	Overall Compliance: No
Severity Score: 22.5			
Codes/Mitigation Info/Possible Solution		Field Measurements/Component Compliance

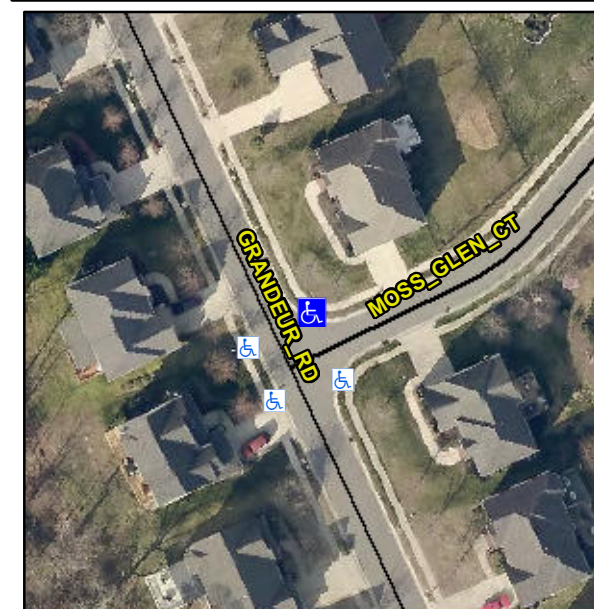
Not Found, R304.5.1, R304.2.2, R304.5.3

Compliance	Description	Data	Compliance	Description	Data
N/A	Ramp Length (in)	45.0	No	Ramp Slope (%)	9.2
No	Ramp Width (in)	41.0	No	Ramp XSlope (%)	3.2
N/A	Flare Type LT	N/A	N/A	Flare Type RT	N/A
N/A	Flare Slope LT (%)	N/A	N/A	Flare Slope RT (%)	N/A
N/A	Flare Traversable LT?	N/A	N/A	Flare Traversable RT?	N/A
N/A	Landing Length (in)	N/A	N/A	DWS Provided?	N/A
N/A	Landing Width (in)	N/A	N/A	DWS Contrast?	N/A
N/A	Landing Slope (%)	N/A	N/A	DWS Length (in)	N/A
N/A	Landing X Slope (%)	N/A	N/A	DWS Full Width?	N/A
N/A	Landing Curb? (Y/N)	N/A	N/A	DWS Offset (in)	N/A
N/A	Shared Landing?	N/A			
N/A	Gutter Ponding?	N/A	N/A	Gutter Slope (%)	N/A
N/A	Gutter Lip Ht (in)	N/A	N/A	Gutter X Slope (%)	N/A
N/A	Painted X Walk1?	No	N/A	Painted X Walk2?	No
	X Walk 1 Direction	To W		X Walk 2 Direction	To S
N/A	X Walk 1 Width (in)	N/A	N/A	X Walk 2 Width (in)	N/A
	X Walk 1 Slope (%)	1.3		X Walk 2 Slope (%)	4.0
	X Walk 1 X Slope (%)	4.9		X Walk 2 X Slope (%)	0.4

N/A	Ramp inside XWalk1?	N/A	N/A	Ramp inside XWalk2?	N/A
	Road Slope (%)	2.6	N/A	Clear Space?	N/A
	Road X Slope (%)	4.1	N/A	Clear Space to XWalk (in)	N/A
N/A	Any Obstructions?	N/A	N/A	Storm Grate/Utility Hazard?	N/A
	Obstruction Type			Storm Grate/Utility Type	
		N/A			N/A
			Yes	Surface Condition? (G/P)	Good

Remove & Replace Curb Ramp With Two New Directional Ramps or Equivalent.
