Access Compliance Report

Public Rights-of-Way

(Curb Ramps)

Intersection ID: 7812	Main Street: SQUIRREL_HILL_RD	Cross Street: THORNWOOD_RD	Location: E
ADA ID: 41B3E4AAC9C7	Ramp Type: PerpDiag	Initial Pass/Fail: Fail	Overall Compliance: No
		Severity Score: 10

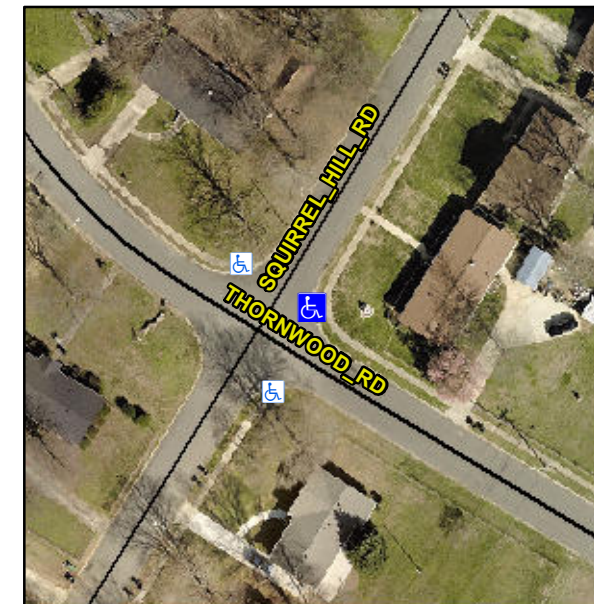
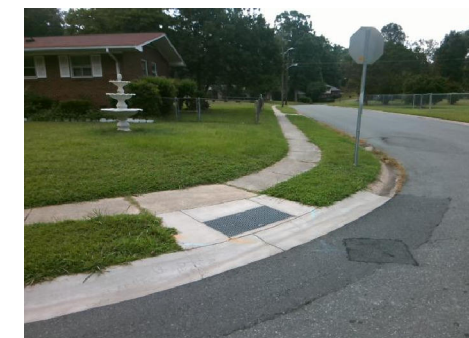
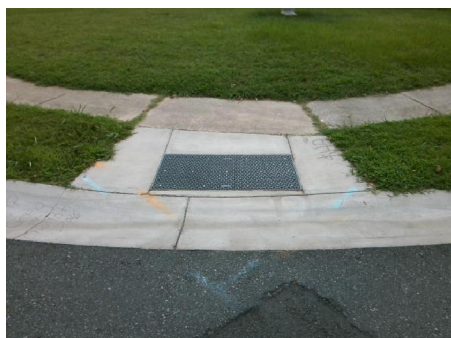
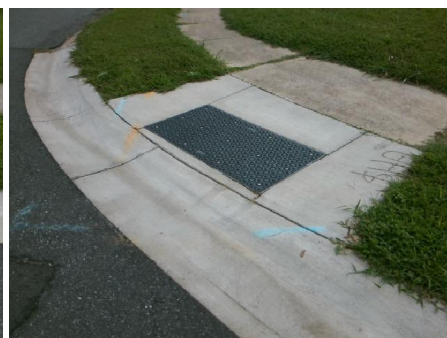
Not Found, R304.5.1, R304.5.3

Compliance	Description	Data	Compliance	Description	Data
N/A	Ramp Length (in)	45.5	Yes	Ramp Slope (%)	7.4
No	Ramp Width (in)	47.5	No	Ramp XSlope (%)	4.3
N/A	Flare Type LT	N/A	N/A	Flare Type RT	N/A
N/A	Flare Slope LT (%)	N/A	N/A	Flare Slope RT (%)	N/A
N/A	Flare Traversable LT?	N/A	N/A	Flare Traversable RT?	N/A
N/A	Landing Length (in)	N/A	N/A	DWS Provided?	N/A
N/A	Landing Width (in)	N/A	N/A	DWS Contrast?	N/A
N/A	Landing Slope (%)	N/A	N/A	DWS Length (in)	N/A
N/A	Landing X Slope (%)	N/A	N/A	DWS Full Width?	N/A
N/A	Landing Curb? (Y/N)	N/A	N/A	DWS Offset (in)	N/A
N/A	Shared Landing?	N/A			
N/A	Gutter Ponding?	N/A	N/A	Gutter Slope (%)	N/A
N/A	Gutter Lip Ht (in)	N/A	N/A	Gutter X Slope (%)	N/A
N/A	Painted X Walk1?	No	N/A	Painted X Walk2?	No
	X Walk 1 Direction	To NW		X Walk 2 Direction	To SW
N/A	X Walk 1 Width (in)	N/A	N/A	X Walk 2 Width (in)	N/A
	X Walk 1 Slope (%)	2.7		X Walk 2 Slope (%)	0.4
	X Walk 1 X Slope (%)	0.6		X Walk 2 X Slope (%)	1.2

N/A	Ramp inside XWalk1?	N/A	N/A	Ramp inside XWalk2?	N/A
	Road Slope (%)	3.1	N/A	Clear Space?	N/A
	Road X Slope (%)	2.8	N/A	Clear Space to XWalk (in)	N/A
N/A	Any Obstructions?	N/A	N/A	Storm Grate/Utility Hazard?	N/A
	Obstruction Type			Storm Grate/Utility Type	
		N/A			N/A
			Yes	Surface Condition? (G/P)	Good

Remove & Replace Curb Ramp With Two New Directional Ramps or Equivalent.
