Access Compliance Report Public Rights-of-Way (Curb Ramps)

Intersection ID: 11444Main Street: ALLEGHANY_STCross Street: MCKINLEY_DRLocation:NEADA ID: 41B5D4F640ACRamp Type: PerpInitial Pass/Fail: FailOverall Compliance: NoSeverity Score: 21.25

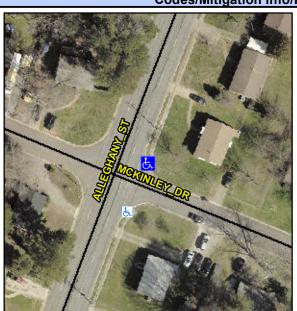
| Possible Solutions: | | | | |
|---|--|--|--|--|
| Not Found, R304.5.1, R304.2.2 | | | | |

| Field Measurements/Component Compliance | | | | | | | | |
|---|---|---|---|---|---|--|--|--|
| N/A | Ramp Length (in) | 71.5 | No | Ramp Slope (%) | 10.3 | | | |
| No | Ramp Width (in) | 44.0 | Yes | Ramp XSlope (%) | 1.3 | | | |

| Possible Solutions: | | | | |
|---|--|--|--|--|
| Remove & Replace Entire Ramp. | | | | |
