Access Compliance Report

Public Rights-of-Way

(Curb Ramps)

Intersection ID: 15095	Main Street: S_LAUREL_AV	Cross Street: WILLOUGHBY_ST	Location: NW
ADA ID: 41B73931FC8F	Ramp Type: PerpDiag	Initial Pass/Fail: Fail	Overall Compliance: No
Severity Score: 13.75			
Codes/Mitigation Info/Possible Solution		Field Measurements/Component Compliance

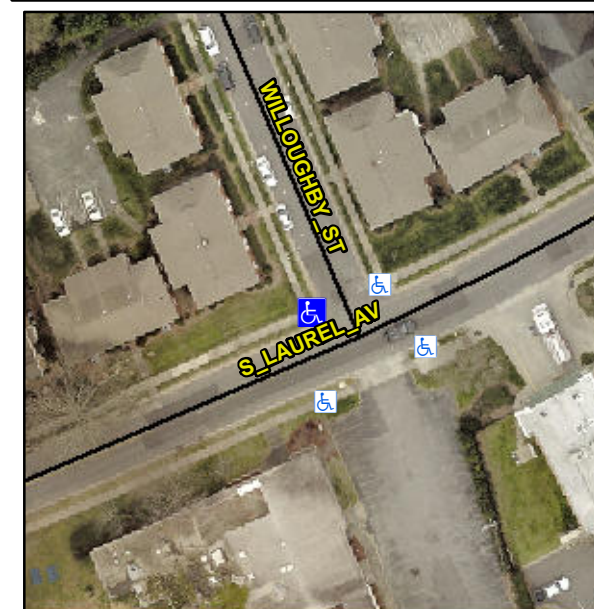
Compliance	Description	Data	Compliance	Description	Data
N/A	Ramp Length (in)	73.0	No	Ramp Slope (%)	9.8
Yes	Ramp Width (in)	49.0	No	Ramp XSlope (%)	2.3
N/A	Flare Type LT	N/A	N/A	Flare Type RT	N/A
N/A	Flare Slope LT (%)	N/A	N/A	Flare Slope RT (%)	N/A
N/A	Flare Traversable LT?	N/A	N/A	Flare Traversable RT?	N/A
N/A	Landing Length (in)	N/A	N/A	DWS Provided?	N/A
N/A	Landing Width (in)	N/A	N/A	DWS Contrast?	N/A
N/A	Landing Slope (%)	N/A	N/A	DWS Length (in)	N/A
N/A	Landing X Slope (%)	N/A	N/A	DWS Full Width?	N/A
N/A	Landing Curb? (Y/N)	N/A	N/A	DWS Offset (in)	N/A
N/A	Shared Landing?	N/A			
N/A	Gutter Ponding?	N/A	N/A	Gutter Slope (%)	N/A
N/A	Gutter Lip Ht (in)	N/A	N/A	Gutter X Slope (%)	N/A
N/A	Painted X Walk1?	No	N/A	Painted X Walk2?	No
	X Walk 1 Direction	To S		X Walk 2 Direction	To E
N/A	X Walk 1 Width (in)	N/A	N/A	X Walk 2 Width (in)	N/A
	X Walk 1 Slope (%)	4.6		X Walk 2 Slope (%)	1.5
	X Walk 1 X Slope (%)	4.3		X Walk 2 X Slope (%)	5.0

N/A	Ramp inside XWalk1?	N/A	N/A	Ramp inside XWalk2?	N/A
	Road Slope (%)	1.5	N/A	Clear Space?	N/A
	Road X Slope (%)	8.3	N/A	Clear Space to XWalk (in)	N/A
N/A	Any Obstructions?	N/A	N/A	Storm Grate/Utility Hazard?	N/A
	Obstruction Type			Storm Grate/Utility Type	
		N/A			N/A
			Yes	Surface Condition? (G/P)	Good

Possible Solutions:

Remove & Replace Curb Ramp With Two New Directional Ramps or Equivalent.

PROW/ADA:

R304.2.2, R304.5.3
