Access Compliance Report

Public Rights-of-Way

(Curb Ramps)

| Intersection ID: 8244 | Main Street: SENIOR_DR | Cross Street: SOUTHWEST_BV | Location: SW |

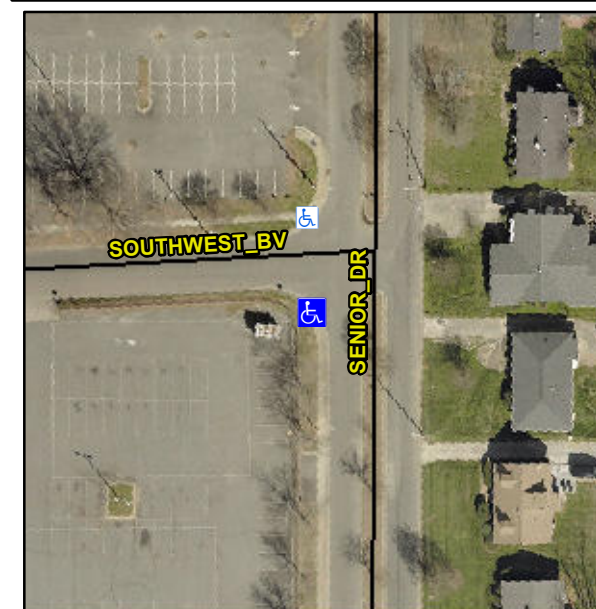
Not Found, R304.5.1, R304.2.2

| Compliance | Description | Data | Compliance | Description | Data |
|---|---|---|---|---|---|
| N/A | Ramp Length (in) | 48.0 | No | Ramp Slope (%) | 10.5 |
| No | Ramp Width (in) | 40.0 | Yes | Ramp XSlope (%) | 0.3 |

Possible Solutions:

Remove & Replace Entire Ramp.

Total Cost: \$ 1850.00
