Access Compliance Report

Public Rights-of-Way

(Curb Ramps)

Intersection ID: 51075	Main Street: MORTEMER_LN	Cross Street: SILVER_GLEN_LN	Location: SW
ADA ID: 41CD87D525DF	Ramp Type: PerpDiag	Initial Pass/Fail: Fail	Overall Compliance: No
Severity Score: 58.75			
Codes/Mitigation Info/Possible Solution		Field Measurements/Component Compliance

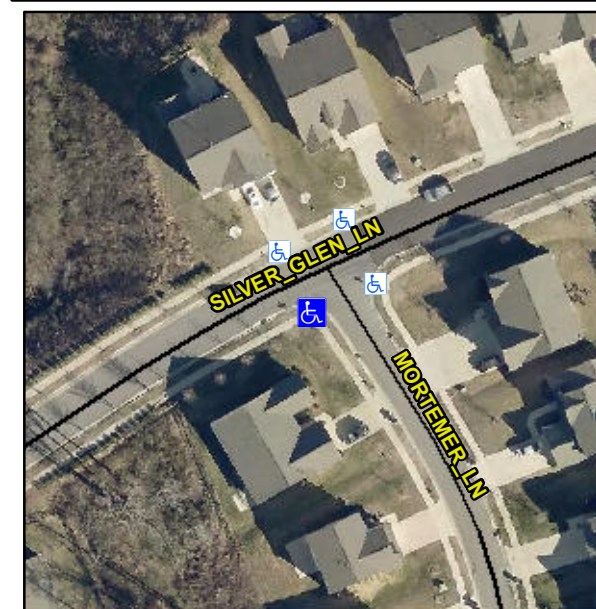
Not Found, R304.5.1, R304.2.2, R304.5.3

Compliance	Description	Data	Compliance	Description	Data
N/A	Ramp Length (in)	48.0	No	Ramp Slope (%)	13.5
No	Ramp Width (in)	44.5	No	Ramp XSlope (%)	9.1
N/A	Flare Type LT	N/A	N/A	Flare Type RT	N/A
N/A	Flare Slope LT (%)	N/A	N/A	Flare Slope RT (%)	N/A
N/A	Flare Traversable LT?	N/A	N/A	Flare Traversable RT?	N/A
N/A	Landing Length (in)	N/A	N/A	DWS Provided?	N/A
N/A	Landing Width (in)	N/A	N/A	DWS Contrast?	N/A
N/A	Landing Slope (%)	N/A	N/A	DWS Length (in)	N/A
N/A	Landing X Slope (%)	N/A	N/A	DWS Full Width?	N/A
N/A	Landing Curb? (Y/N)	N/A	N/A	DWS Offset (in)	N/A
N/A	Shared Landing?	N/A			
N/A	Gutter Ponding?	N/A	N/A	Gutter Slope (%)	N/A
N/A	Gutter Lip Ht (in)	2.0	N/A	Gutter X Slope (%)	N/A
N/A	Painted X Walk1?	No	N/A	Painted X Walk2?	No
	X Walk 1 Direction	To E		X Walk 2 Direction	To N
N/A	X Walk 1 Width (in)	N/A	N/A	X Walk 2 Width (in)	N/A
	X Walk 1 Slope (%)	7.4		X Walk 2 Slope (%)	1.1
	X Walk 1 X Slope (%)	4.5		X Walk 2 X Slope (%)	9.3

N/A	Ramp inside XWalk1?	N/A	N/A	Ramp inside XWalk2?	N/A
	Road Slope (%)	11.8	N/A	Clear Space?	N/A
	Road X Slope (%)	1.1	N/A	Clear Space to XWalk (in)	N/A
N/A	Any Obstructions?	N/A	N/A	Storm Grate/Utility Hazard?	N/A
	Obstruction Type			Storm Grate/Utility Type	
		N/A			N/A
		Yes		Surface Condition? (G/P)	Good

Remove & Replace Curb Ramp With Two New Directional Ramps or Equivalent.
