# Access Compliance Report

## Public Rights-of-Way

### (Curb Ramps)

| Intersection ID: 27495 | Main Street: BALLANTYNE COMMONS PY | Cross Street: NORTH COMMUNITY HOUSE RD | Location: NW |

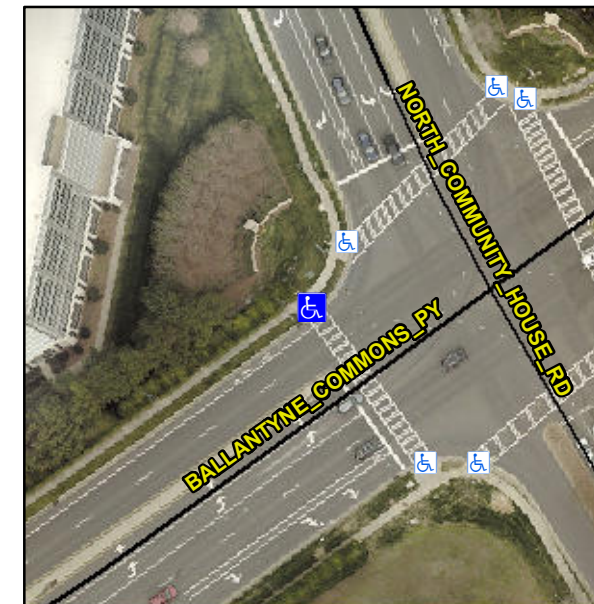
| ADA ID: 41D1354698B1 | Ramp Type: Perp | Initial Pass/Fail: Fail | Overall Compliance: No |
| | | | Severity Score: 10 |

Surveyor Notes:

**N/A**

PROW/ADA:

**Not Found, R304.5.1**

| Compliance | Description | Data | Compliance | Description | Data |
|---|---|---|---|---|---|
| No | Ramp Width (in) | 47.0 | Yes | Ramp XSlope (%) | 3.3 |

Possible Solutions:

**Remove & Replace Entire Ramp.**

Total Cost: \$ 1850.00
