# Access Compliance Report

## Public Rights-of-Way

### (Curb Ramps)

| Intersection ID: 9676 | Main Street: WOODWARD_AV | Cross Street: LUCENA_ST | Location: NW |

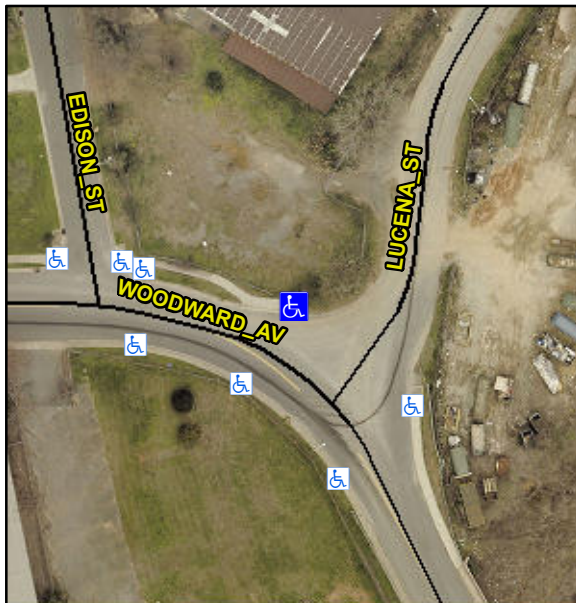
**NO RT SW, LT RP < 5%**

**R304.2.1, R304.2.2-Perp, R304.3.2-Para**

| Compliance | Description | Data | Compliance | Description | Data |
|---|---|---|---|---|---|
| No | Landing Length (in) | 59.0 | Yes | DWS Provided? | Yes |
| No | Landing Slope (%) | 2.3 | Yes | DWS Length (in) | 24.0 |

**Remove & Replace Curb Ramp With Two New Directional Ramps or Equivalent.**
