Access Compliance Report

Public Rights-of-Way

(Curb Ramps)

| Intersection ID: 10024872 | Main Street: DEWITT_LN | Cross Street: N/A | Location: NE |

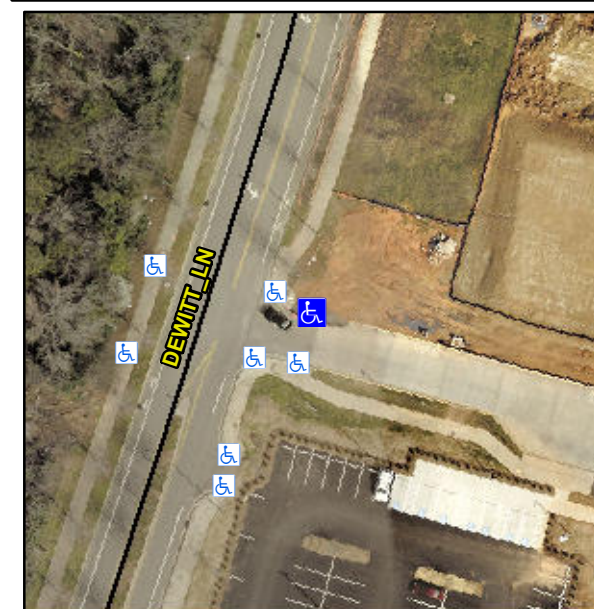
| ADA ID: 41D35633693B | Ramp Type: Perp | Initial Pass/Fail: Fail | Overall Compliance: No |
| Severity Score: 13.75 | | | |

R304.2.2, R304.5.3

| Compliance | Description | Data | Compliance | Description | Data |
|---|---|---|---|---|---|
| N/A | Ramp Length (in) | 96.0 | No | Ramp Slope (%) | 8.9 |
| Yes | Ramp Width (in) | 48.0 | No | Ramp XSlope (%) | 3.6 |

Remove & Replace Entire Ramp.

Total Cost: \$ 1850.00
