Access Compliance Report

Public Rights-of-Way

(Curb Ramps)

| Intersection ID: 46745 | Main Street: CUMBERLAND COVE DR | Cross Street: NORMANS LANDING DR | Location: SE |

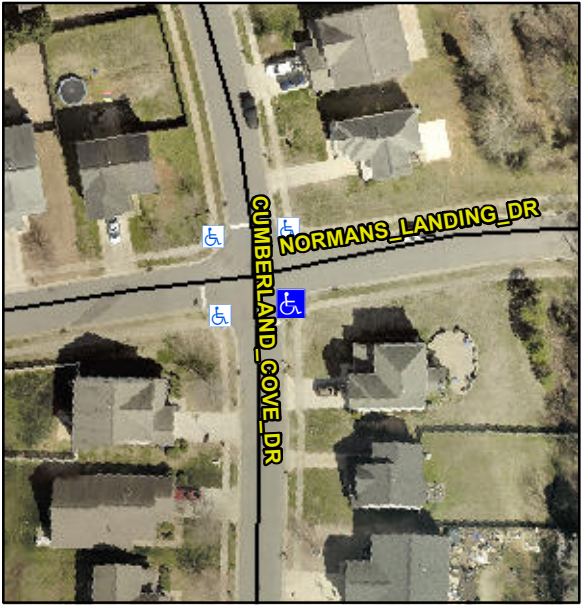
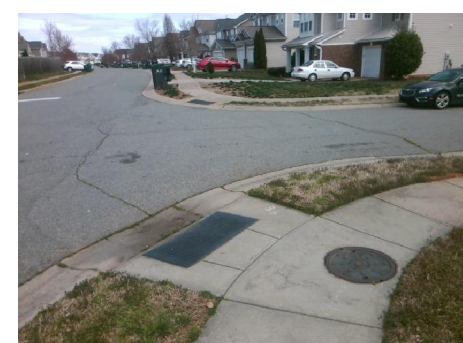
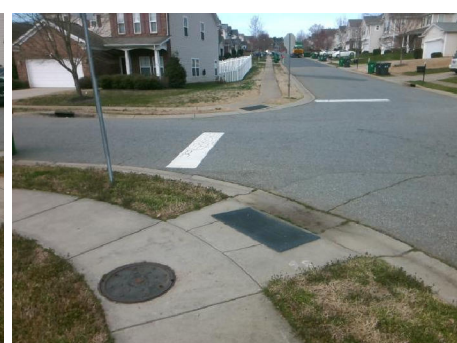
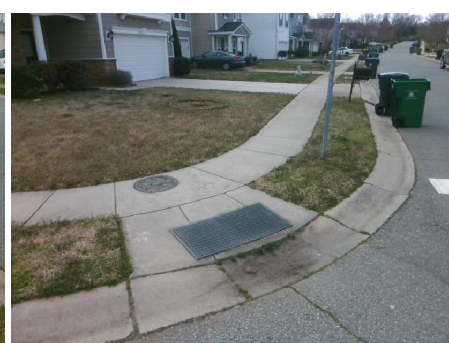
| ADA ID: 41D97DF022DC | Ramp Type: PerpDiag | Initial Pass/Fail: Fail | Overall Compliance: No |

| Codes/Mitigation Info/Possible Solution | | | Field Measurements/Component Compliance | | |
|--|---|--|---|---|---|
| | Remove & Replace Curb Ramp With Two New Directional Ramps or Equivalent. | | No | Ramp Length (in) | 49.0 |
| | | | No | Ramp Width (in) | 26.0 |
| | | | 4.3 | X Walk 2 Slope (%) | 6.1 |
| | | | 3.0 | X Walk 2 X Slope (%) | 2.4 |

| Codes/Mitigation Info/Possible Solution | | | Field Measurements/Component Compliance | | |
|--|---|--|---|---|---|
| | Possible Solutions: | | Compliance | Description | Data |
