Access Compliance Report Public Rights-of-Way (Curb Ramps)

Intersection ID: 44155 Main Street: MEADOW_KNOLL_DR Cross Street: JUNIPER_DR Location: N

ADA ID: 41E07890251D Ramp Type: Perp Initial Pass/Fail: Fail Overall Compliance: No Severity Score: 25

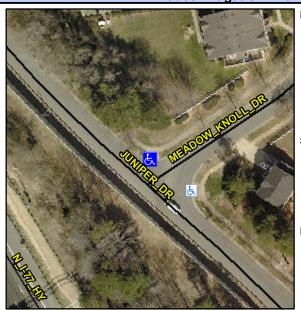
Not Found, R304.5.3

Yes Ramp Slope (%) N/A Ramp Length (in) 84.5 5.6 No Ramp XSlope (%) Yes Ramp Width (in) 55.5 9.2 N/A N/A Flare Type LT N/A Flare Type RT N/A N/A N/A N/A Flare Slope RT (%) N/A Flare Slope LT (%) N/A Flare Traversable LT? N/A N/A Flare Traversable RT? N/A N/A N/A N/A **DWS Provided?** N/A Landing Length (in) N/A Landing Width (in) N/A N/A **DWS Contrast?** N/A N/A N/A N/A Landing Slope (%) DWS Length (in) N/A N/A Landing X Slope (%) N/A N/A DWS Full Width? N/A N/A Landing Curb? (Y/N) N/A N/A DWS Offset (in) N/A N/A N/A Shared Landing? N/A **Gutter Ponding?** N/A N/A Gutter Slope (%) N/A N/A Gutter Lip Ht (in) N/A N/A Gutter X Slope (%) N/A N/A Painted X Walk1? No N/A Painted X Walk2? N/A X Walk 1 Direction To SE X Walk 2 Direction N/A N/A N/A N/A X Walk 1 Width (in) X Walk 2 Width (in) N/A X Walk 1 Slope (%) 7.5 X Walk 2 Slope (%) N/A X Walk 1 X Slope (%) 3.3 X Walk 2 X Slope (%) N/A N/A N/A N/A Ramp inside XWalk2? Ramp inside XWalk1? N/A Road Slope (%) N/A N/A Clear Space? N/A N/A Road X Slope (%) N/A Clear Space to XWalk (in) N/A N/A N/A Any Obstructions? N/A Storm Grate/Utility Hazard? N/A **Obstruction Type** Storm Grate/Utility Type N/A N/A Yes Surface Condition? (G/P) Good

Remove & Replace Entire Ramp.
