# Access Compliance Report

## Public Rights-of-Way

### (Curb Ramps)

Intersection ID: 11994	Main Street: BELVEDERE_AV	Cross Street: THE_PLAZA	Location: SE
ADA ID: 41E32FA3CF57	Ramp Type: PerpDiag	Initial Pass/Fail: Fail	Overall Compliance: No
		Severity Score: 22.5

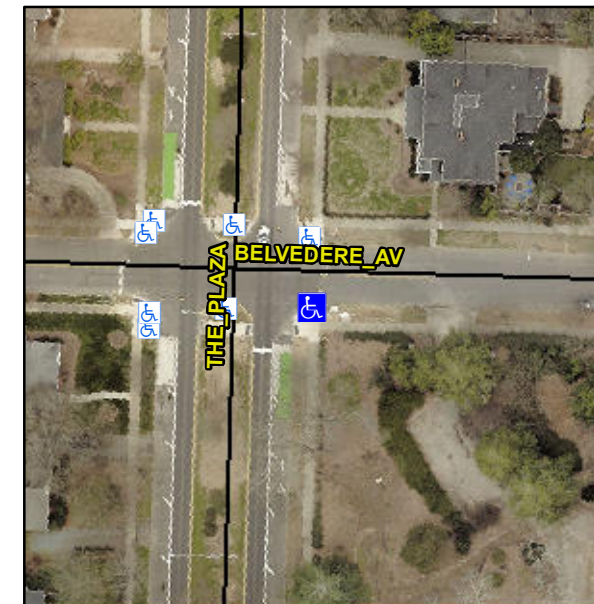
Compliance	Description	Data	Compliance	Description	Data
N/A	Ramp Length (in)	78.5	No	Ramp Slope (%)	8.9
No	Ramp Width (in)	44.5	No	Ramp XSlope (%)	2.5
N/A	Flare Type LT	N/A	N/A	Flare Type RT	N/A
N/A	Flare Slope LT (%)	N/A	N/A	Flare Slope RT (%)	N/A
N/A	Flare Traversable LT?	N/A	N/A	Flare Traversable RT?	N/A
N/A	Landing Length (in)	N/A	N/A	DWS Provided?	N/A
N/A	Landing Width (in)	N/A	N/A	DWS Contrast?	N/A
N/A	Landing Slope (%)	N/A	N/A	DWS Length (in)	N/A
N/A	Landing X Slope (%)	N/A	N/A	DWS Full Width?	N/A
N/A	Landing Curb? (Y/N)	N/A	N/A	DWS Offset (in)	N/A
N/A	Shared Landing?	N/A			
N/A	Gutter Ponding?	N/A	N/A	Gutter Slope (%)	N/A
N/A	Gutter Lip Ht (in)	N/A	N/A	Gutter X Slope (%)	N/A
N/A	Painted X Walk1?	Yes	N/A	Painted X Walk2?	Yes
	X Walk 1 Direction	To N		X Walk 2 Direction	To W
N/A	X Walk 1 Width (in)	110.0	N/A	X Walk 2 Width (in)	136.0
	X Walk 1 Slope (%)	3.1		X Walk 2 Slope (%)	1.4
	X Walk 1 X Slope (%)	2.0		X Walk 2 X Slope (%)	1.4

N/A	Ramp inside XWalk1?	Yes	N/A	Ramp inside XWalk2?	Yes
	Road Slope (%)	1.3	N/A	Clear Space?	N/A
	Road X Slope (%)	4.4	N/A	Clear Space to XWalk (in)	N/A
N/A	Any Obstructions?	N/A	N/A	Storm Grate/Utility Hazard?	N/A
	Obstruction Type			Storm Grate/Utility Type	
		N/A			N/A
		Yes		Surface Condition? (G/P)	Good

**Remove & Replace Curb Ramp With Two New Directional Ramps or Equivalent.**

**R304.5.1, R304.2.2, R304.5.3**
