Access Compliance Report

Public Rights-of-Way

(Curb Ramps)

Intersection ID: 11981	Main Street: W_6TH_ST	Cross Street: N_CHURCH_ST	Location: W
ADA ID: 41EAE900EFFC	Ramp Type: PerpDiag	Initial Pass/Fail: Fail	Overall Compliance: No
			Severity Score: 13.75

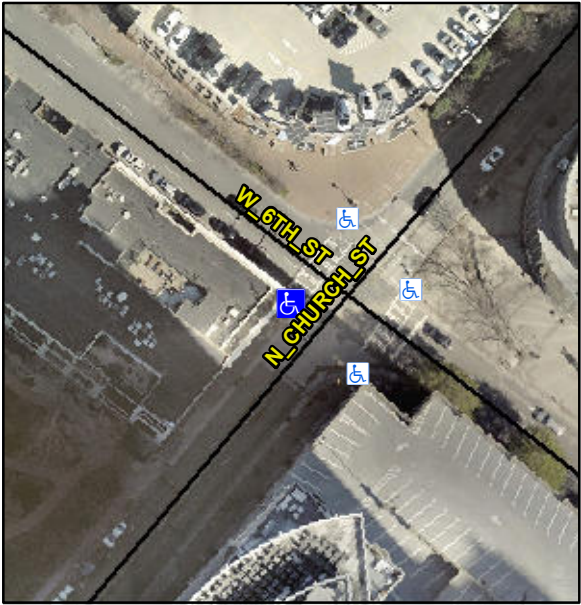
Compliance	Description	Data	Compliance	Description	Data
N/A	Ramp Length (in)	53.0	No	Ramp Slope (%)	10.3
Yes	Ramp Width (in)	54.0	No	Ramp XSlope (%)	3.2
N/A	Flare Type LT	N/A	N/A	Flare Type RT	N/A
N/A	Flare Slope LT (%)	N/A	N/A	Flare Slope RT (%)	N/A
N/A	Flare Traversable LT?	N/A	N/A	Flare Traversable RT?	N/A
N/A	Landing Length (in)	N/A	N/A	DWS Provided?	N/A
N/A	Landing Width (in)	N/A	N/A	DWS Contrast?	N/A
N/A	Landing Slope (%)	N/A	N/A	DWS Length (in)	N/A
N/A	Landing X Slope (%)	N/A	N/A	DWS Full Width?	N/A
N/A	Landing Curb? (Y/N)	N/A	N/A	DWS Offset (in)	N/A
N/A	Shared Landing?	N/A			
N/A	Gutter Ponding?	N/A	N/A	Gutter Slope (%)	N/A
N/A	Gutter Lip Ht (in)	N/A	N/A	Gutter X Slope (%)	N/A
N/A	Painted X Walk1?	Yes	N/A	Painted X Walk2?	Yes
	X Walk 1 Direction	To SE		X Walk 2 Direction	To NE
N/A	X Walk 1 Width (in)	111.0	N/A	X Walk 2 Width (in)	124.0
	X Walk 1 Slope (%)	2.5		X Walk 2 Slope (%)	2.0
	X Walk 1 X Slope (%)	3.1		X Walk 2 X Slope (%)	1.0

N/A	Ramp inside XWalk1?	Yes	N/A	Ramp inside XWalk2?	Yes
	Road Slope (%)	0.2	N/A	Clear Space?	N/A
	Road X Slope (%)	0.9	N/A	Clear Space to XWalk (in)	N/A
N/A	Any Obstructions?	N/A	N/A	Storm Grate/Utility Hazard?	N/A
	Obstruction Type			Storm Grate/Utility Type	
		N/A			N/A
		Yes		Surface Condition? (G/P)	Good

Possible Solutions:				
	Remove & Replace Curb Ramp With Two New Directional Ramps or Equivalent.				
	Surveyor Notes:				
	N/A				
	PROW/ADA:				
	R304.2.2, R304.5.3				
Street 1 Name	N CHURCH ST				
Stop Condition-Street 2	Signal				
Street 2 Name	W 6TH ST				
Stop Condition-Street 1	Signal				
Total Cost:		\$	3200.00
