Access Compliance Report

Public Rights-of-Way

(Curb Ramps)

Intersection ID: 20860	Main Street: CROWNPOINT_EXECUTIVE_DR	Cross Street: KREFELD_DR	Location: SW
ADA ID: 4202F4F101F8	Ramp Type: Perp	Initial Pass/Fail: Fail	Overall Compliance: No
Severity Score: 10			
Codes/Mitigation Info/Possible Solution		Field Measurements/Component Compliance

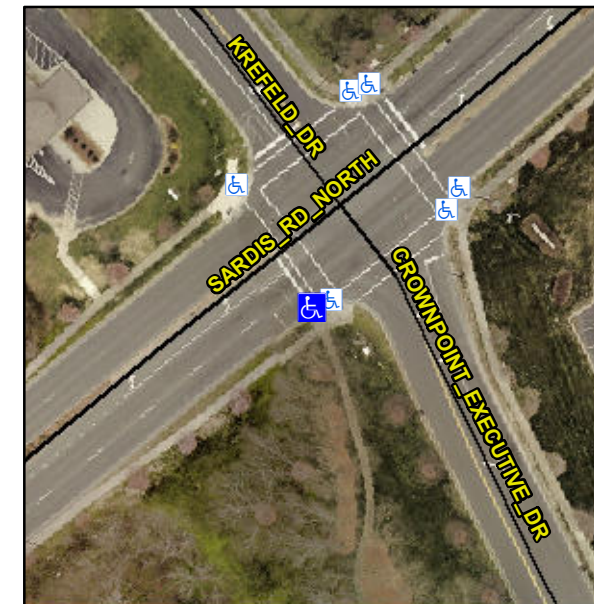
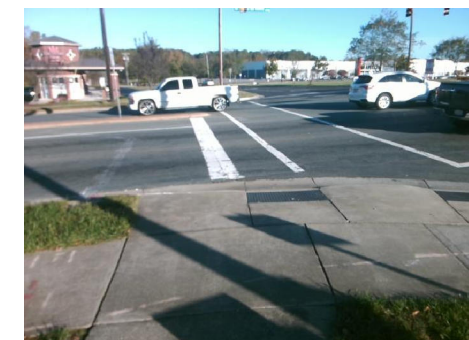
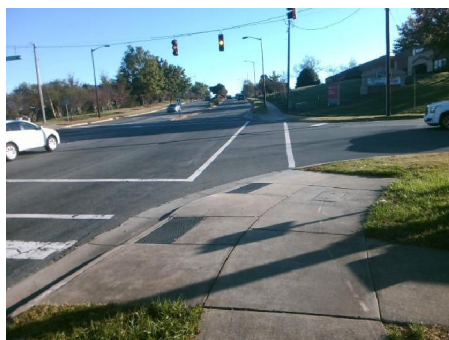
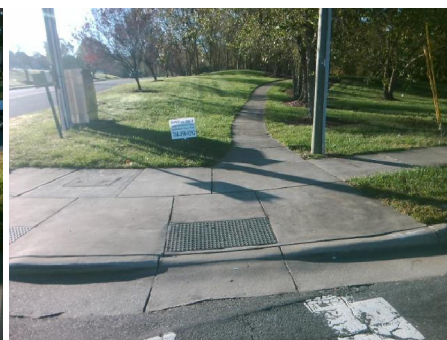
Not Found, R304.5.1

Compliance	Description	Data	Compliance	Description	Data
N/A	Ramp Length (in)	64.0	Yes	Ramp Slope (%)	7.1
No	Ramp Width (in)	46.0	Yes	Ramp XSlope (%)	2.1
N/A	Flare Type LT	N/A	N/A	Flare Type RT	N/A
N/A	Flare Slope LT (%)	N/A	N/A	Flare Slope RT (%)	N/A
N/A	Flare Traversable LT?	N/A	N/A	Flare Traversable RT?	N/A
N/A	Landing Length (in)	N/A	N/A	DWS Provided?	N/A
N/A	Landing Width (in)	N/A	N/A	DWS Contrast?	N/A
N/A	Landing Slope (%)	N/A	N/A	DWS Length (in)	N/A
N/A	Landing X Slope (%)	N/A	N/A	DWS Full Width?	N/A
N/A	Landing Curb? (Y/N)	N/A	N/A	DWS Offset (in)	N/A
N/A	Shared Landing?	N/A			
N/A	Gutter Ponding?	N/A	N/A	Gutter Slope (%)	N/A
N/A	Gutter Lip Ht (in)	N/A	N/A	Gutter X Slope (%)	N/A
N/A	Painted X Walk1?	No	N/A	Painted X Walk2?	N/A
	X Walk 1 Direction	To NW		X Walk 2 Direction	N/A
N/A	X Walk 1 Width (in)	N/A	N/A	X Walk 2 Width (in)	N/A
	X Walk 1 Slope (%)	0.8		X Walk 2 Slope (%)	N/A
	X Walk 1 X Slope (%)	2.7		X Walk 2 X Slope (%)	N/A

N/A	Ramp inside XWalk1?	N/A	N/A	Ramp inside XWalk2?	N/A
	Road Slope (%)	N/A	N/A	Clear Space?	N/A
	Road X Slope (%)	N/A	N/A	Clear Space to XWalk (in)	N/A
N/A	Any Obstructions?	N/A	N/A	Storm Grate/Utility Hazard?	N/A
	Obstruction Type			Storm Grate/Utility Type	
		N/A			N/A
		Yes		Surface Condition? (G/P)	Good

Remove & Replace Entire Ramp.
