# Access Compliance Report

## Public Rights-of-Way

### (Curb Ramps)

Intersection ID: 24469	Main Street: MIROW_PL	Cross Street: SAINTFIELD_PL	Location: SW
ADA ID: 420316DEE038	Ramp Type: PerpDiag	Initial Pass/Fail: Fail	Overall Compliance: No
Severity Score: 12.5			
Codes/Mitigation Info/Possible Solution		Field Measurements/Component Compliance

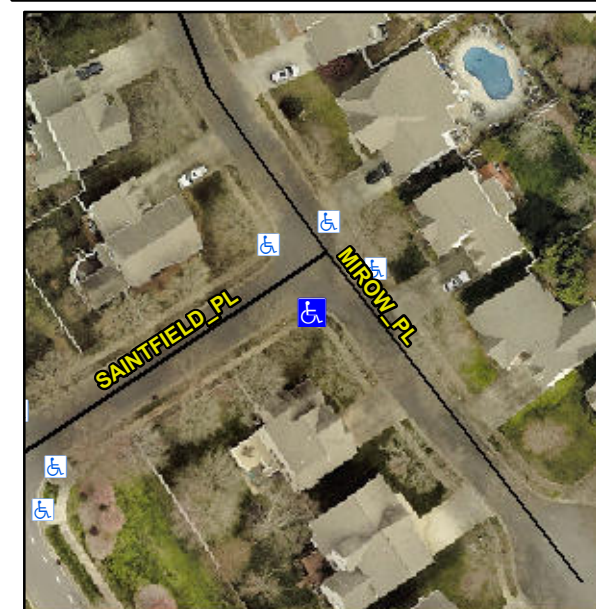
**Not Found, R304.5.3**

Compliance	Description	Data	Compliance	Description	Data
N/A	Ramp Length (in)	48.0	Yes	Ramp Slope (%)	7.0
Yes	Ramp Width (in)	48.0	No	Ramp XSlope (%)	5.2
N/A	Flare Type LT	N/A	N/A	Flare Type RT	N/A
N/A	Flare Slope LT (%)	N/A	N/A	Flare Slope RT (%)	N/A
N/A	Flare Traversable LT?	N/A	N/A	Flare Traversable RT?	N/A
N/A	Landing Length (in)	N/A	N/A	DWS Provided?	N/A
N/A	Landing Width (in)	N/A	N/A	DWS Contrast?	N/A
N/A	Landing Slope (%)	N/A	N/A	DWS Length (in)	N/A
N/A	Landing X Slope (%)	N/A	N/A	DWS Full Width?	N/A
N/A	Landing Curb? (Y/N)	N/A	N/A	DWS Offset (in)	N/A
N/A	Shared Landing?	N/A			
N/A	Gutter Ponding?	N/A	N/A	Gutter Slope (%)	N/A
N/A	Gutter Lip Ht (in)	N/A	N/A	Gutter X Slope (%)	N/A
N/A	Painted X Walk1?	No	N/A	Painted X Walk2?	No
	X Walk 1 Direction	To E		X Walk 2 Direction	To N
N/A	X Walk 1 Width (in)	N/A	N/A	X Walk 2 Width (in)	N/A
	X Walk 1 Slope (%)	4.0		X Walk 2 Slope (%)	1.4
	X Walk 1 X Slope (%)	3.2		X Walk 2 X Slope (%)	4.4

N/A	Ramp inside XWalk1?	N/A	N/A	Ramp inside XWalk2?	N/A
	Road Slope (%)	6.4	N/A	Clear Space?	N/A
	Road X Slope (%)	3.0	N/A	Clear Space to XWalk (in)	N/A
N/A	Any Obstructions?	N/A	N/A	Storm Grate/Utility Hazard?	N/A
	Obstruction Type			Storm Grate/Utility Type	
		N/A			N/A
		Yes		Surface Condition? (G/P)	Good

**Remove & Replace Curb Ramp With Two New Directional Ramps or Equivalent.**

Total Cost: \$ 3200.00
