Access Compliance Report

Public Rights-of-Way

(Curb Ramps)

Intersection ID: 47468	Main Street: MILLSTREAM RIDGE DR	Cross Street: ELENDIL LN	Location: SE
ADA ID: 421CEDEB6127	Ramp Type: Perp	Initial Pass/Fail: Fail	Overall Compliance: No
Severity Score: 30			
Codes/Mitigation Info/Possible Solution		Field Measurements/Component Compliance

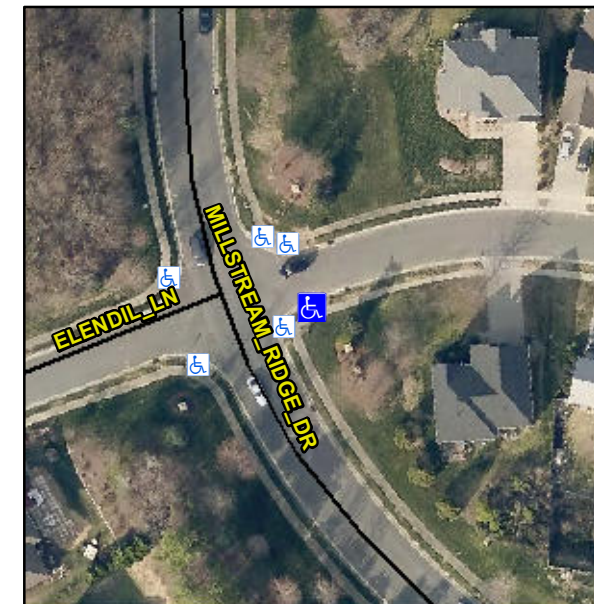
Compliance	Description	Data	Compliance	Description	Data
N/A	Ramp Length (in)	48.0	No	Ramp Slope (%)	9.6
No	Ramp Width (in)	32.0	Yes	Ramp XSlope (%)	1.1
N/A	Flare Type LT	N/A	N/A	Flare Type RT	N/A
N/A	Flare Slope LT (%)	N/A	N/A	Flare Slope RT (%)	N/A
N/A	Flare Traversable LT?	N/A	N/A	Flare Traversable RT?	N/A
N/A	Landing Length (in)	N/A	N/A	DWS Provided?	N/A
N/A	Landing Width (in)	N/A	N/A	DWS Contrast?	N/A
N/A	Landing Slope (%)	N/A	N/A	DWS Length (in)	N/A
N/A	Landing X Slope (%)	N/A	N/A	DWS Full Width?	N/A
N/A	Landing Curb? (Y/N)	N/A	N/A	DWS Offset (in)	N/A
N/A	Shared Landing?	N/A			
N/A	Gutter Ponding?	N/A	N/A	Gutter Slope (%)	N/A
N/A	Gutter Lip Ht (in)	N/A	N/A	Gutter X Slope (%)	N/A
N/A	Painted X Walk1?	No	N/A	Painted X Walk2?	N/A
	X Walk 1 Direction	To N		X Walk 2 Direction	N/A
N/A	X Walk 1 Width (in)	N/A	N/A	X Walk 2 Width (in)	N/A
	X Walk 1 Slope (%)	5.6		X Walk 2 Slope (%)	N/A
	X Walk 1 X Slope (%)	2.5		X Walk 2 X Slope (%)	N/A

N/A	Ramp inside XWalk1?	N/A	N/A	Ramp inside XWalk2?	N/A
	Road Slope (%)	N/A	N/A	Clear Space?	N/A
	Road X Slope (%)	N/A	N/A	Clear Space to XWalk (in)	N/A
N/A	Any Obstructions?	N/A	N/A	Storm Grate/Utility Hazard?	N/A
	Obstruction Type			Storm Grate/Utility Type	
		N/A			N/A
			Yes	Surface Condition? (G/P)	Good

Possible Solutions:

Remove & Replace Entire Ramp.

R304.5.1, R304.2.2
