## Access Compliance Report Public Rights-of-Way (Curb Ramps)

Intersection ID: 52169	Main St	Main Street: AVERY_MEADOWS_DR			Cross Street: BEATTIES_FORD_RD				S
ADA ID: 421DB7C965F3	Ramp T	Ramp Type: Perp			Initial Pass/Fail: Fail Overall Compliance:			o Severity Score:	13.75
Codes/Mitigation Info/Possible Solution				Field Measurements/Component Compliance

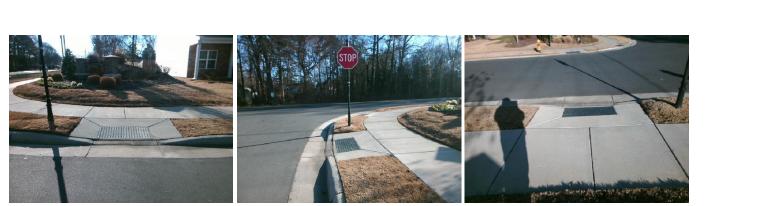
C. Sand	Possible Solutions:		Compliance Description Data C			Comp	Compliance Description Data	
		Remove & Replace Entire Rar	np.	N/A	Ramp Length (in)	49.0	No	Ramp Slope (%)	8.4
	The state of the state		•	Yes	Ramp Width (in)	48.0	No	Ramp XSlope (%)	3.0
	A PER MAN			N/A	Flare Type LT	N/A	N/A	Flare Type RT	N/A
	100 March			N/A	Flare Slope LT (%)	N/A	N/A	Flare Slope RT (%)	N/A
	A A A A A A A A A A A A A A A A A A A			N/A	Flare Traversable LT?	N/A	N/A	Flare Traversable RT?	N/A

- 18 1 Ha			N/A	Shared Landing?	N/A			
G.	1 . 18 . 1	PROW/ADA:		N/A	Gutter Ponding?	N/A	N/A	Gutter Slope (%)	N/A
	1 140 111	Not Found, R304.2.2, R304.5.3	3	N/A	Gutter Lip Ht (in)	N/A	N/A	Gutter X Slope (%)	N/A
	and the l			N/A	Painted X Walk1?	No	N/A	Painted X Walk2?	N/A
	and the second	×			X Walk 1 Direction	To N		X Walk 2 Direction	N/A
	All all a			N/A	X Walk 1 Width (in)	N/A	N/A	X Walk 2 Width (in)	N/A
Street 1 Name A	VERY MEADOWS DR	_			X Walk 1 Slope (%)	0.1		X Walk 2 Slope (%)	N/A
Stop Condition-Street 2	StopSign				X Walk 1 X Slope (%)	2.2		X Walk 2 X Slope (%)	N/A
Street 2 Name	N/A			N/A	Ramp inside XWalk1?	N/A	N/A	Ramp inside XWalk2?	N/A
Stop Condition-Street 1	N/A				Road Slope (%)	N/A	N/A	Clear Space?	N/A
					Road X Slope (%)	N/A	N/A	Clear Space to XWalk (in)	N/A
				N/A	Any Obstructions?	N/A	N/A	Storm Grate/Utility Hazard?	N/A
		Total Cost: \$	1850.00		Obstruction Type			Storm Grate/Utility Type
