Access Compliance Report

Public Rights-of-Way

(Curb Ramps)

Intersection ID: 3250	Main Street: BILLINGHAM_DR	Cross Street: HIGHCROFT_LN	Location:	N
ADA ID: 422CCF385891	Ramp Type: Perp	Initial Pass/Fail: Fail	Overall Compliance: No	Severity Score: 8.75

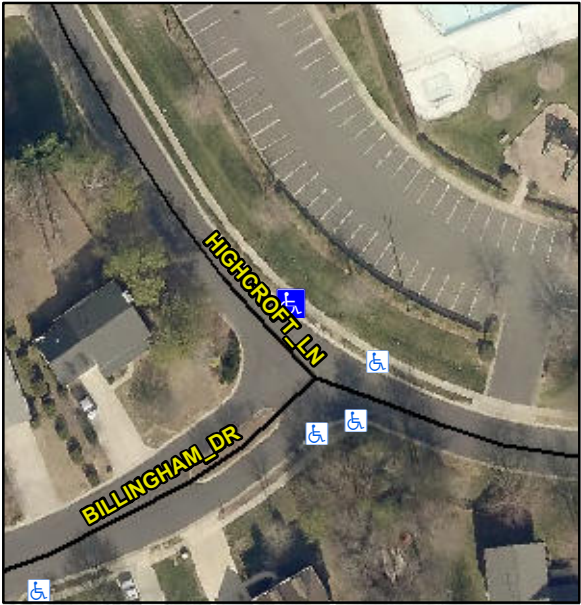
Possible Solutions:		Compliance	Description	Data
	Remove & Replace Entire Ramp.		N/A	Ramp Length (in)	47.0
			No	Ramp Width (in)	47.0
			N/A	Flare Type LT	N/A
			N/A	Flare Slope LT (%)	N/A
			N/A	Flare Traversable LT?	N/A
			N/A	Landing Length (in)	N/A
			N/A	Landing Width (in)	N/A
			N/A	Landing Slope (%)	N/A
			N/A	Landing X Slope (%)	N/A
<p>Surveyor Notes:</p> <p>N/A</p> <p>PROW/ADA:</p> <p>Not Found, R304.5.1</p>			N/A	Flare Type RT	N/A
			N/A	Flare Slope RT (%)	N/A
			N/A	Flare Traversable RT?	N/A
			N/A	DWS Provided?	N/A
			N/A	DWS Contrast?	N/A
			N/A	DWS Length (in)	N/A
			N/A	DWS Full Width?	N/A
			N/A	DWS Offset (in)	N/A
			N/A	Shared Landing?	N/A
			N/A	Gutter Ponding?	N/A
			N/A	Gutter Lip Ht (in)	N/A
			N/A	Painted X Walk1?	No
				X Walk 1 Direction	To SW
			N/A	X Walk 1 Width (in)	N/A
				X Walk 1 Slope (%)	4.8
				X Walk 1 X Slope (%)	0.3

N/A	Ramp inside XWalk1?	N/A
			N/A	Ramp inside XWalk2?	N/A
			N/A	Road Slope (%)	N/A
			N/A	Road X Slope (%)	N/A
			N/A	Any Obstructions?	N/A
				Obstruction Type	
			N/A	Clear Space?	N/A
			N/A	Clear Space to XWalk (in)	N/A
			N/A	Storm Grate/Utility Hazard?	N/A
				Storm Grate/Utility Type	
			N/A		N/A
			Yes	Surface Condition? (G/P)	Good
