Access Compliance Report

Public Rights-of-Way

(Curb Ramps)

Intersection ID: 44850	Main Street: STEELE_CREEK_RD	Cross Street: SHOPTON_RD_WEST	Location: SW
ADA ID: 422DF1A6FCB5	Ramp Type: Perp	Initial Pass/Fail: Fail	Overall Compliance: No
		Severity Score: 22.5

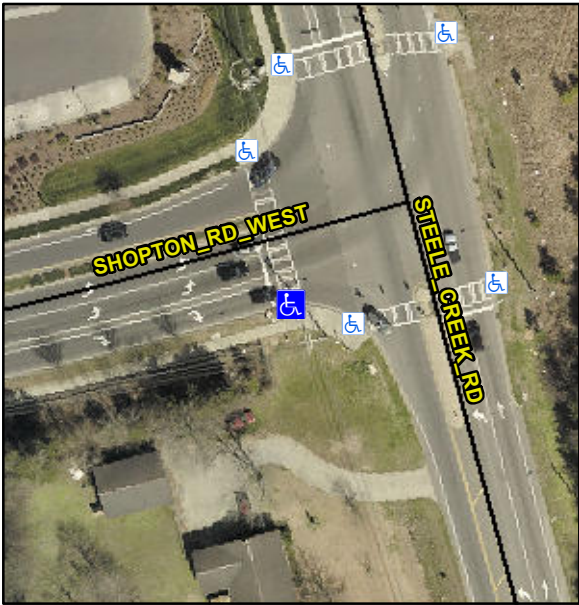
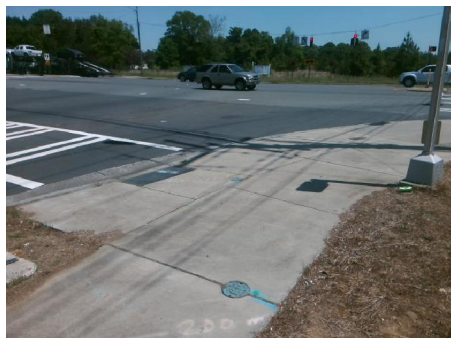
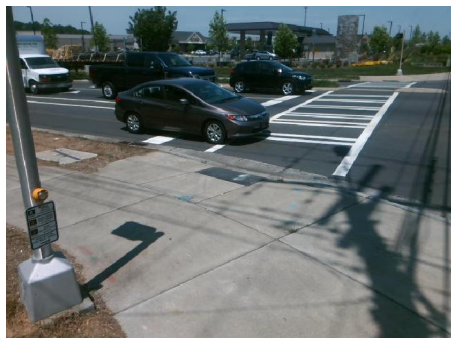
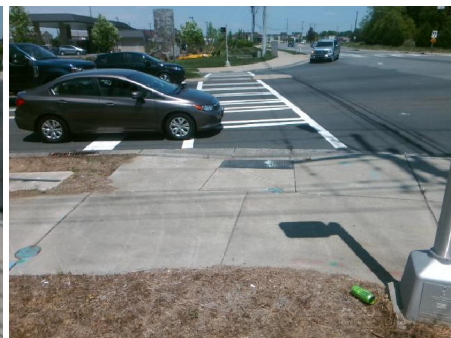
Possible Solutions:		Compliance			Description			Data	Compliance			Description			Data
	Remove & Replace Entire Ramp.		N/A	Ramp Length (in)		71.0		No	Ramp Slope (%)		10.0					
			No	Ramp Width (in)		40.0		No	Ramp XSlope (%)		3.7					
			N/A	Flare Type LT		N/A		N/A	Flare Type RT		N/A					
			N/A	Flare Slope LT (%)		N/A		N/A	Flare Slope RT (%)		N/A					
			N/A	Flare Traversable LT?		N/A		N/A	Flare Traversable RT?		N/A					
			N/A	Landing Length (in)		N/A		N/A	DWS Provided?		N/A					
			N/A	Landing Width (in)		N/A		N/A	DWS Contrast?		N/A					
			N/A	Landing Slope (%)		N/A		N/A	DWS Length (in)		N/A					
			N/A	Landing X Slope (%)		N/A		N/A	DWS Full Width?		N/A					
Surveyor Notes:		N/A	N/A	Landing Curb? (Y/N)		N/A		N/A	DWS Offset (in)		N/A					
			N/A	Shared Landing?		N/A										
PROW/ADA:		R304.5.1, R304.2.2, R304.5.3	N/A	Gutter Ponding?		N/A		N/A	Gutter Slope (%)		N/A

N/A	Gutter Lip Ht (in)		N/A		N/A	Gutter X Slope (%)		N/A					
			N/A	Painted X Walk1?		Yes		N/A	Painted X Walk2?		N/A					
				X Walk 1 Direction		To N			X Walk 2 Direction		N/A					
			N/A	X Walk 1 Width (in)		108.0		N/A	X Walk 2 Width (in)		N/A					
				X Walk 1 Slope (%)		2.6			X Walk 2 Slope (%)		N/A					
				X Walk 1 X Slope (%)		3.0			X Walk 2 X Slope (%)		N/A					
Street 1 Name		SHOPTON RD WEST	N/A	Ramp inside XWalk1?		Yes		N/A	Ramp inside XWalk2?		N/A					
Stop Condition-Street 2		Signal		Road Slope (%)		N/A		N/A	Clear Space?		N/A					
Street 2 Name		N/A		Road X Slope (%)		N/A		N/A	Clear Space to XWalk (in)		N/A					
Stop Condition-Street 1		N/A		Any Obstructions?		N/A		N/A	Storm Grate/Utility Hazard?		N/A					
				Obstruction Type					Storm Grate/Utility Type							
								N/A			N/A					
								Yes	Surface Condition? (G/P)		Good					
Total Cost:		\$ 1850.00
