# Access Compliance Report

## Public Rights-of-Way

### (Curb Ramps)

Intersection ID: N/A	Main Street: INVERNESS_BAY_RD	Cross Street: PERTH_MOOR_RD	Location: NE
ADA ID: 423AFBFDC940	Ramp Type: Perp	Initial Pass/Fail: Fail	Overall Compliance: No
Severity Score: 37.5			
Codes/Mitigation Info/Possible Solution		Field Measurements/Component Compliance

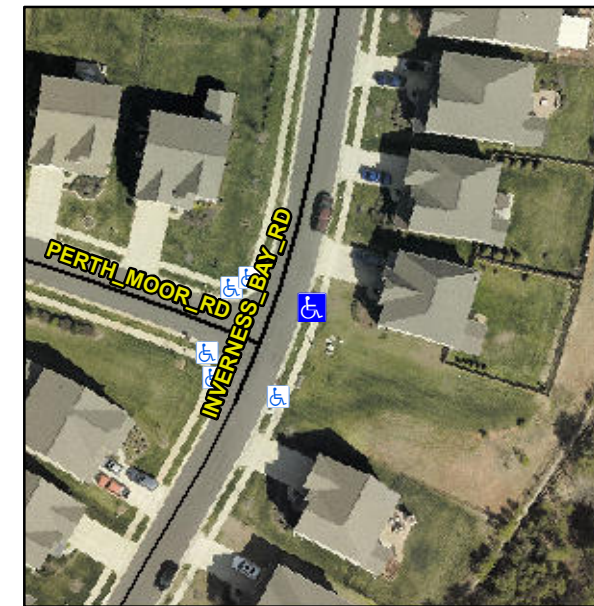
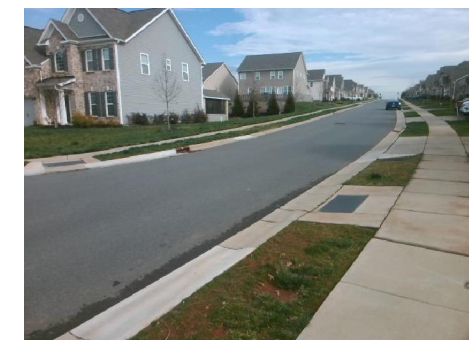
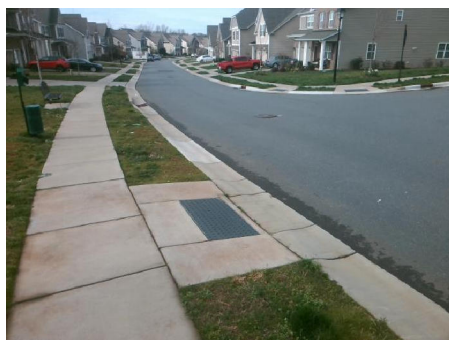
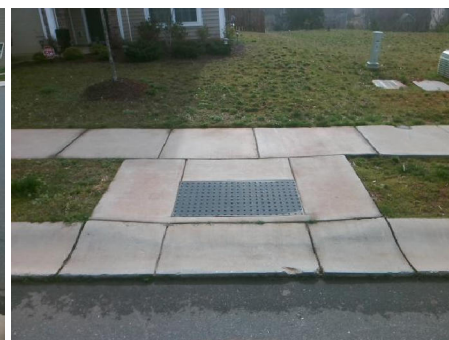
**Not Found, R304.2.2, R304.5.3**

Compliance	Description	Data	Compliance	Description	Data
N/A	Ramp Length (in)	48.0	No	Ramp Slope (%)	10.7
Yes	Ramp Width (in)	48.0	No	Ramp XSlope (%)	7.1
N/A	Flare Type LT	N/A	N/A	Flare Type RT	N/A
N/A	Flare Slope LT (%)	N/A	N/A	Flare Slope RT (%)	N/A
N/A	Flare Traversable LT?	N/A	N/A	Flare Traversable RT?	N/A
N/A	Landing Length (in)	N/A	N/A	DWS Provided?	N/A
N/A	Landing Width (in)	N/A	N/A	DWS Contrast?	N/A
N/A	Landing Slope (%)	N/A	N/A	DWS Length (in)	N/A
N/A	Landing X Slope (%)	N/A	N/A	DWS Full Width?	N/A
N/A	Landing Curb? (Y/N)	N/A	N/A	DWS Offset (in)	N/A
N/A	Shared Landing?	N/A			
N/A	Gutter Ponding?	N/A	N/A	Gutter Slope (%)	N/A
N/A	Gutter Lip Ht (in)	2.0	N/A	Gutter X Slope (%)	N/A
N/A	Painted X Walk1?	No	N/A	Painted X Walk2?	N/A
	X Walk 1 Direction	To NW		X Walk 2 Direction	N/A
N/A	X Walk 1 Width (in)	N/A	N/A	X Walk 2 Width (in)	N/A
	X Walk 1 Slope (%)	2.1		X Walk 2 Slope (%)	N/A
	X Walk 1 X Slope (%)	5.0		X Walk 2 X Slope (%)	N/A

**Remove & Replace Entire Ramp.**

Total Cost: \$ 1850.00
