# Access Compliance Report

## Public Rights-of-Way

### (Curb Ramps)

| Intersection ID: 15639 | Main Street: EASTOVER_RD | Cross Street: HEMPSTEAD_PL | Location: SW |

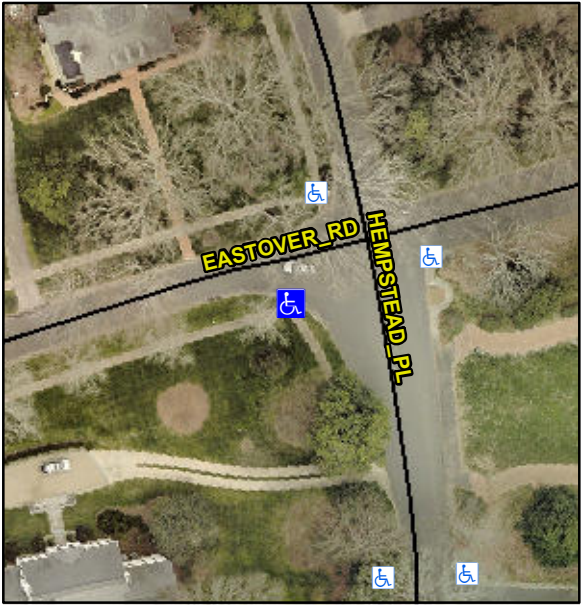
| Codes/Mitigation Info/Possible Solution | | Field Measurements/Component Compliance | | | |
|---|---|---|---|--|--|
| | <b>Not Found, R304.5.3, R304.2.1, R304.2.2-Perp, R304.3.2-Para</b> | | | | |

| Compliance | Description | Data | Compliance | Description | Data |
|---|---|---|---|---|---|
| Yes | Ramp Width (in) | 48.0 | No | Ramp XSlope (%) | 3.0 |
| No | Landing Length (in) | N/A | Yes | DWS Provided? | Yes |
| No | Landing Width (in) | N/A | Yes | DWS Contrast? | Yes |
| No | Landing Slope (%) | N/A | Yes | DWS Length (in) | 25.5 |
| No | Landing X Slope (%) | N/A | Yes | DWS Full Width? | Yes |
| Yes | Gutter Lip Ht (in) | 0.0 | No | Gutter X Slope (%) | 2.3 |

| Codes/Mitigation Info/Possible Solution | | Field Measurements/Component Compliance | | | |
|---|---|---|---|--|--|
| | <b>Remove &amp; Replace Curb Ramp With Two New Directional Ramps or Equivalent. Remove &amp; Replace Gutter.</b> | | | | |
| Total Cost: | | \$ | 3950.00 | | |
