Access Compliance Report

Public Rights-of-Way

(Curb Ramps)

Intersection ID: 5408	Main Street: CARVER_PL	Cross Street: ROCKWELL_BV	Location: W
ADA ID: 424E6814F4B8	Ramp Type: Para	Initial Pass/Fail: Fail	Overall Compliance: No
Severity Score: 43.75			
Codes/Mitigation Info/Possible Solution		Field Measurements/Component Compliance

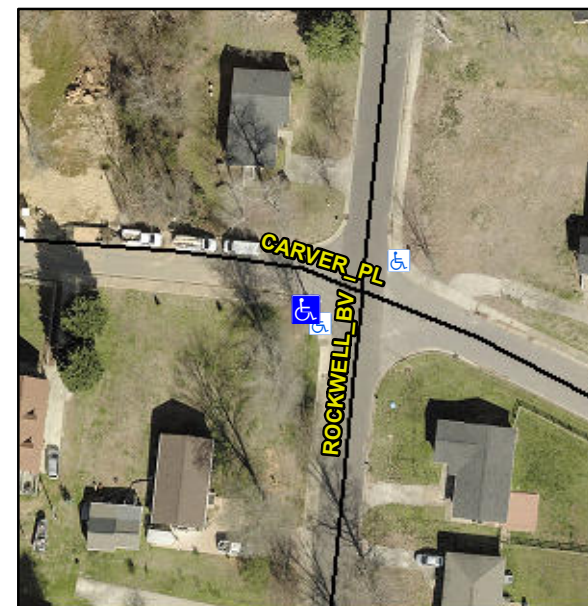
POWER POLE OBS

R304.5.1, R304.3.2, R304.5.3

Compliance	Description	Data	Compliance	Description	Data
N/A	Ramp Length LT (in)	32.0	N/A	Ramp Length RT (in)	56.0
No	Ramp Width LT (in)	41.0	No	Ramp Width RT (in)	35.0
No	Ramp Slope LT (%)	14.3	Yes	Ramp Slope RT (%)	6.5
Yes	Ramp XSlope LT (%)	1.2	No	Ramp XSlope RT (%)	2.6
N/A	Landing Length (in)	N/A	N/A	DWS Provided?	N/A
N/A	Landing Width (in)	N/A	N/A	DWS Contrast?	N/A
N/A	Landing Slope (%)	N/A	N/A	DWS Length (in)	N/A
N/A	Landing X Slope (%)	N/A	N/A	DWS Full Width?	N/A
N/A	Landing Curb? (Y/N)	N/A	N/A	DWS Offset (in)	N/A
N/A	Shared Landing?	N/A			
N/A	Gutter Ponding?	N/A	N/A	Gutter Slope (%)	N/A
N/A	Gutter Lip Ht (in)	N/A	N/A	Gutter X Slope (%)	N/A
N/A	Painted X Walk1?	No	N/A	Painted X Walk2?	N/A
	X Walk 1 Direction	To N		X Walk 2 Direction	N/A
N/A	X Walk 1 Width (in)	N/A	N/A	X Walk 2 Width (in)	N/A
	X Walk 1 Slope (%)	3.1		X Walk 2 Slope (%)	N/A
	X Walk 1 X Slope (%)	4.1		X Walk 2 X Slope (%)	N/A
N/A	Ramp inside XWalk1?	N/A	N/A	Ramp inside XWalk2?	N/A

Road Slope (%)	N/A	N/A	Clear Space?	N/A
	Road X Slope (%)	N/A	N/A	Clear Space to XWalk (in)	N/A
N/A	Any Obstructions?	N/A	N/A	Storm Grate/Utility Hazard?	N/A
	Obstruction Type			Storm Grate/Utility Type	
		N/A			N/A
			Yes	Surface Condition? (G/P)	Good
			N/A	Curb Slope (%)	15.1

Remove & Replace Entire Ramp.
