# Access Compliance Report

## Public Rights-of-Way

### (Curb Ramps)

Intersection ID: 31277	Main Street: GARRETT_GRIGG_RD	Cross Street: TIGER_LN	Location: S
ADA ID: 425A4778CDA9	Ramp Type: PerpDiag	Initial Pass/Fail: Fail	Overall Compliance: No
			Severity Score: 33.75

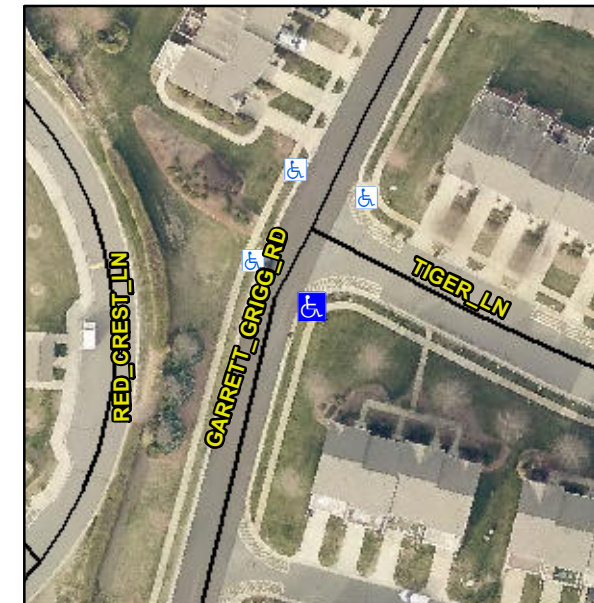
Compliance	Description	Data	Compliance	Description	Data
N/A	Ramp Length (in)	62.0	Yes	Ramp Slope (%)	5.1
No	Ramp Width (in)	40.5	No	Ramp XSlope (%)	9.8
N/A	Flare Type LT	N/A	N/A	Flare Type RT	N/A
N/A	Flare Slope LT (%)	N/A	N/A	Flare Slope RT (%)	N/A
N/A	Flare Traversable LT?	N/A	N/A	Flare Traversable RT?	N/A
N/A	Landing Length (in)	N/A	N/A	DWS Provided?	N/A
N/A	Landing Width (in)	N/A	N/A	DWS Contrast?	N/A
N/A	Landing Slope (%)	N/A	N/A	DWS Length (in)	N/A
N/A	Landing X Slope (%)	N/A	N/A	DWS Full Width?	N/A
N/A	Landing Curb? (Y/N)	N/A	N/A	DWS Offset (in)	N/A
N/A	Shared Landing?	N/A			
N/A	Gutter Ponding?	N/A	N/A	Gutter Slope (%)	N/A
N/A	Gutter Lip Ht (in)	N/A	N/A	Gutter X Slope (%)	N/A
N/A	Painted X Walk1?	No	N/A	Painted X Walk2?	No
	X Walk 1 Direction	To NE		X Walk 2 Direction	To NW
N/A	X Walk 1 Width (in)	N/A	N/A	X Walk 2 Width (in)	N/A
	X Walk 1 Slope (%)	5.5		X Walk 2 Slope (%)	4.5
	X Walk 1 X Slope (%)	3.9		X Walk 2 X Slope (%)	4.6

N/A	Ramp inside XWalk1?	N/A	N/A	Ramp inside XWalk2?	N/A
	Road Slope (%)	7.3	N/A	Clear Space?	N/A
	Road X Slope (%)	0.7	N/A	Clear Space to XWalk (in)	N/A
N/A	Any Obstructions?	N/A	N/A	Storm Grate/Utility Hazard?	N/A
	Obstruction Type			Storm Grate/Utility Type	
		N/A			N/A
			Yes	Surface Condition? (G/P)	Good

**Remove & Replace Curb Ramp With Two New Directional Ramps or Equivalent.**

**R304.5.1, R304.5.3**

Total Cost: \$ 3200.00
