Access Compliance Report

Public Rights-of-Way

(Curb Ramps)

Intersection ID: 24751	Main Street: CINNAMON_FIELD_RD	Cross Street: WILD_HEATHER_CT	Location: NW
ADA ID: 425A63D1AD5F	Ramp Type: Perp	Initial Pass/Fail: Fail	Overall Compliance: No
			Severity Score: 33.75
Codes/Mitigation Info/Possible Solution		Field Measurements/Component Compliance

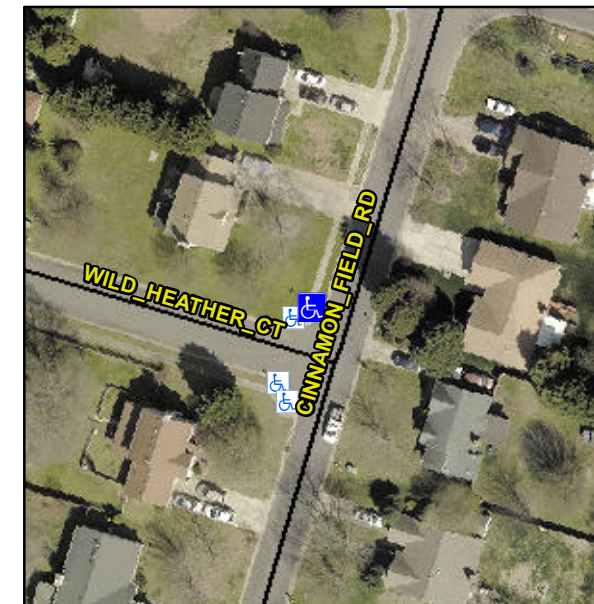
Not Found, R304.5.1, R304.2.2, R304.5.3

Compliance	Description	Data	Compliance	Description	Data
N/A	Ramp Length (in)	92.0	No	Ramp Slope (%)	10.1
No	Ramp Width (in)	36.0	No	Ramp XSlope (%)	6.5
N/A	Flare Type LT	N/A	N/A	Flare Type RT	N/A
N/A	Flare Slope LT (%)	N/A	N/A	Flare Slope RT (%)	N/A
N/A	Flare Traversable LT?	N/A	N/A	Flare Traversable RT?	N/A
N/A	Landing Length (in)	N/A	N/A	DWS Provided?	N/A
N/A	Landing Width (in)	N/A	N/A	DWS Contrast?	N/A
N/A	Landing Slope (%)	N/A	N/A	DWS Length (in)	N/A
N/A	Landing X Slope (%)	N/A	N/A	DWS Full Width?	N/A
N/A	Landing Curb? (Y/N)	N/A	N/A	DWS Offset (in)	N/A
N/A	Shared Landing?	N/A			
N/A	Gutter Ponding?	N/A	N/A	Gutter Slope (%)	N/A
N/A	Gutter Lip Ht (in)	N/A	N/A	Gutter X Slope (%)	N/A
N/A	Painted X Walk1?	No	N/A	Painted X Walk2?	N/A
	X Walk 1 Direction	To SE		X Walk 2 Direction	N/A
N/A	X Walk 1 Width (in)	N/A	N/A	X Walk 2 Width (in)	N/A
	X Walk 1 Slope (%)	0.4		X Walk 2 Slope (%)	N/A
	X Walk 1 X Slope (%)	2.8		X Walk 2 X Slope (%)	N/A

N/A	Ramp inside XWalk1?	N/A	N/A	Ramp inside XWalk2?	N/A
	Road Slope (%)	N/A	N/A	Clear Space?	N/A
	Road X Slope (%)	N/A	N/A	Clear Space to XWalk (in)	N/A
N/A	Any Obstructions?	N/A	N/A	Storm Grate/Utility Hazard?	N/A
	Obstruction Type			Storm Grate/Utility Type	
		N/A			N/A
			Yes	Surface Condition? (G/P)	Good

Remove & Replace Entire Ramp.
