Access Compliance Report

Public Rights-of-Way

(Curb Ramps)

Intersection ID: 3273	Main Street: BILLINGHAM_DR	Cross Street: PROSPERITY_CHURCH_RD	Location: SE
ADA ID: 425E832145B5	Ramp Type: PerpDiag	Initial Pass/Fail: Fail	Overall Compliance: No
Severity Score: 22.5			
Codes/Mitigation Info/Possible Solution		Field Measurements/Component Compliance

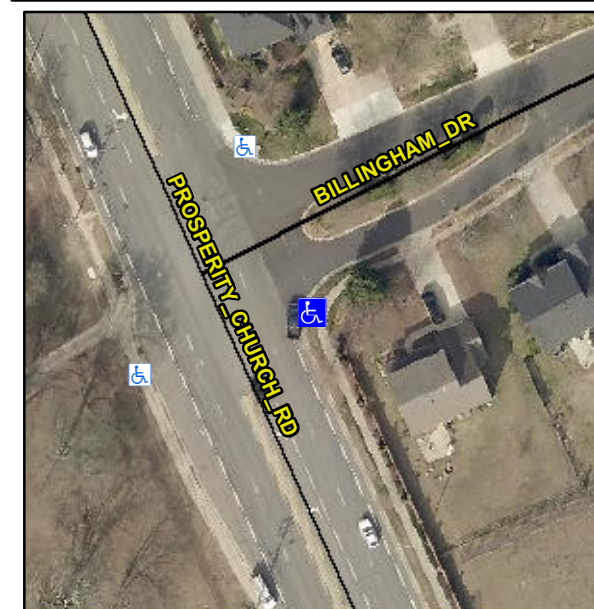
R304.5.1, R304.2.2, R304.5.3

Compliance	Description	Data	Compliance	Description	Data
N/A	Ramp Length (in)	72.0	No	Ramp Slope (%)	8.7
No	Ramp Width (in)	38.0	No	Ramp XSlope (%)	4.8
N/A	Flare Type LT	N/A	N/A	Flare Type RT	N/A
N/A	Flare Slope LT (%)	N/A	N/A	Flare Slope RT (%)	N/A
N/A	Flare Traversable LT?	N/A	N/A	Flare Traversable RT?	N/A
N/A	Landing Length (in)	N/A	N/A	DWS Provided?	N/A
N/A	Landing Width (in)	N/A	N/A	DWS Contrast?	N/A
N/A	Landing Slope (%)	N/A	N/A	DWS Length (in)	N/A
N/A	Landing X Slope (%)	N/A	N/A	DWS Full Width?	N/A
N/A	Landing Curb? (Y/N)	N/A	N/A	DWS Offset (in)	N/A
N/A	Shared Landing?	N/A			
N/A	Gutter Ponding?	N/A	N/A	Gutter Slope (%)	N/A
N/A	Gutter Lip Ht (in)	N/A	N/A	Gutter X Slope (%)	N/A
N/A	Painted X Walk1?	No	N/A	Painted X Walk2?	No
	X Walk 1 Direction	To N		X Walk 2 Direction	To W
N/A	X Walk 1 Width (in)	N/A	N/A	X Walk 2 Width (in)	N/A
	X Walk 1 Slope (%)	1.0		X Walk 2 Slope (%)	5.5
	X Walk 1 X Slope (%)	5.8		X Walk 2 X Slope (%)	0.9

N/A	Ramp inside XWalk1?	N/A	N/A	Ramp inside XWalk2?	N/A
	Road Slope (%)	5.3	N/A	Clear Space?	N/A
	Road X Slope (%)	5.4	N/A	Clear Space to XWalk (in)	N/A
N/A	Any Obstructions?	N/A	N/A	Storm Grate/Utility Hazard?	N/A
	Obstruction Type			Storm Grate/Utility Type	
		N/A			N/A
			Yes	Surface Condition? (G/P)	Good

Remove & Replace Curb Ramp With Two New Directional Ramps or Equivalent.

Total Cost: \$ 3200.00
