Access Compliance Report Public Rights-of-Way (Curb Ramps)

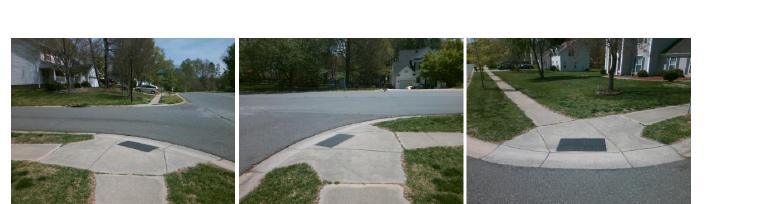
Intersection ID: 5518	ection ID: 5518 Main Street: MISTY_VALE_RD			Street:	NORTHWOODS_FORE	Location:	NW			
ADA ID: 42651AE8C946 Ramp Type: Perp			Initial I	Initial Pass/Fail: Fail Overall Compliance: No				o Severity Score:	12.5	
Codes/Mitigation Info/Possible Solution				Field Measurements/Component Compliance						
		Possible Solutions:		Compliance Description Data Compliance Descrip					Data	
A CONTRACTOR		Remove & Replace Entire Ramp).	N/A	Ramp Length (in)	70.0	Yes	Ramp Slope (%)	7.4

S. Rouge	· · · · · · · · · · · · · · · · · · ·		Yes	Ramp Width (in)	62.0	No	Ramp XSlope (%)	5.1	
	fin - F			N/A	Flare Type LT	N/A	N/A	Flare Type RT	N/A	
				N/A	Flare Slope LT (%)	N/A	N/A	Flare Slope RT (%)	N/A	
				N/A	Flare Traversable LT?	N/A	N/A	Flare Traversable RT?	N/A	
	1 BU- 1			N/A	Landing Length (in)	N/A	N/A	DWS Provided?	N/A	
		Surveyor Notes:		N/A	Landing Width (in)	N/A	N/A	DWS Contrast?	N/A
