Intersection ID: 12416	Main Street: CHESTNUT_AV	Cross Street: THOMAS_AV	Location:	NE
ADA ID: 4268FB760E7F	Ramp Type: PerpDiag	Initial Pass/Fail: Fail	Overall Compliance: No	Severity Score: 33.75

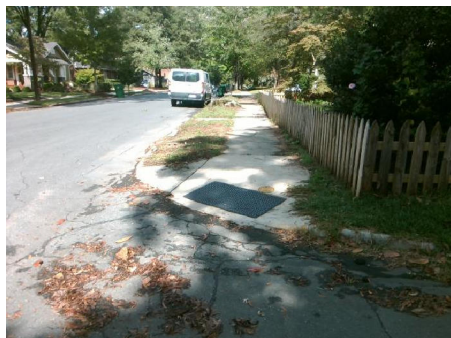
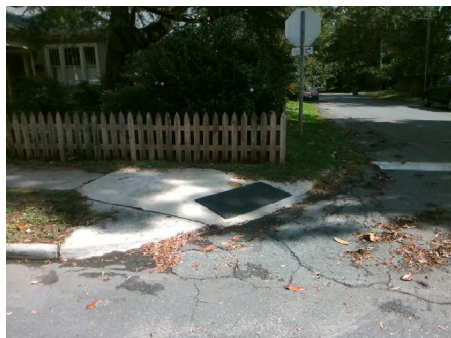
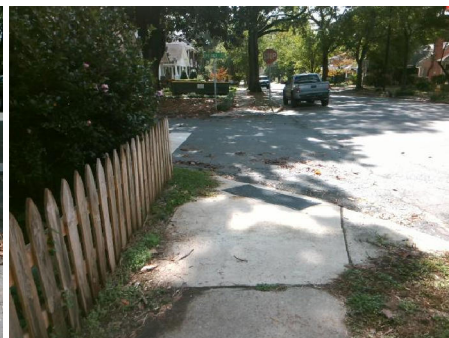
Possible Solutions:		Compliance	Description	Data	Compliance	Description	Data
	Remove & Replace Curb Ramp With Two New Directional Ramps or Equivalent.		N/A	Ramp Length (in)	59.0	No	Ramp Slope (%)	16.5
			No	Ramp Width (in)	47.0	Yes	Ramp XSlope (%)	0.9
			N/A	Flare Type LT	N/A	N/A	Flare Type RT	N/A
			N/A	Flare Slope LT (%)	N/A	N/A	Flare Slope RT (%)	N/A
			N/A	Flare Traversable LT?	N/A	N/A	Flare Traversable RT?	N/A
			N/A	Landing Length (in)	N/A	N/A	DWS Provided?	N/A
			N/A	Landing Width (in)	N/A	N/A	DWS Contrast?	N/A
			N/A	Landing Slope (%)	N/A	N/A	DWS Length (in)	N/A
			N/A	Landing X Slope (%)	N/A	N/A	DWS Full Width?	N/A
Surveyor Notes:		N/A	N/A	Landing Curb? (Y/N)	N/A	N/A	DWS Offset (in)	N/A
PROW/ADA:		R304.5.1, R304.2.2	N/A	Shared Landing?	N/A			
			N/A	Gutter Ponding?	N/A	N/A	Gutter Slope (%)	N/A
			N/A	Gutter Lip Ht (in)	N/A	N/A	Gutter X Slope (%)	N/A

N/A	Painted X Walk1?	No	N/A	Painted X Walk2?	No
				X Walk 1 Direction	To W		X Walk 2 Direction	To S
			N/A	X Walk 1 Width (in)	N/A	N/A	X Walk 2 Width (in)	N/A
				X Walk 1 Slope (%)	3.4		X Walk 2 Slope (%)	0.5
				X Walk 1 X Slope (%)	1.2		X Walk 2 X Slope (%)	2.5
			N/A	Ramp inside XWalk1?	N/A	N/A	Ramp inside XWalk2?	N/A
				Road Slope (%)	5.1	N/A	Clear Space?	N/A
				Road X Slope (%)	3.9	N/A	Clear Space to XWalk (in)	N/A
			N/A	Any Obstructions?	N/A	N/A	Storm Grate/Utility Hazard?	N/A
				Obstruction Type			Storm Grate/Utility Type	
					N/A			N/A
						Yes	Surface Condition? (G/P)	Good
Street 1 Name		THOMAS AV						
Stop Condition-Street 2		StopSign						
Street 2 Name		CHESTNUT AV						
Stop Condition-Street 1		StopSign						
Total Cost:		\$ 3200.00
