Access Compliance Report

Public Rights-of-Way

(Curb Ramps)

Intersection ID: 15160	Main Street: GRIFFITH_ST	Cross Street: S_TRYON_ST	Location: SE
ADA ID: 427ADB107ED7	Ramp Type: Perp	Initial Pass/Fail: Fail	Overall Compliance: No
Severity Score: 12.5			
Codes/Mitigation Info/Possible Solution		Field Measurements/Component Compliance

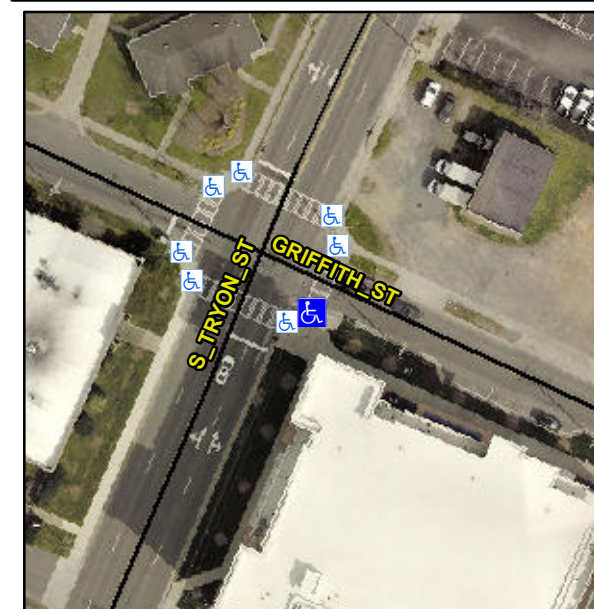
Not Found, R304.2.2

Compliance	Description	Data	Compliance	Description	Data
N/A	Ramp Length (in)	103.0	No	Ramp Slope (%)	8.5
Yes	Ramp Width (in)	48.0	Yes	Ramp XSlope (%)	1.7
N/A	Flare Type LT	N/A	N/A	Flare Type RT	N/A
N/A	Flare Slope LT (%)	N/A	N/A	Flare Slope RT (%)	N/A
N/A	Flare Traversable LT?	N/A	N/A	Flare Traversable RT?	N/A
N/A	Landing Length (in)	N/A	N/A	DWS Provided?	N/A
N/A	Landing Width (in)	N/A	N/A	DWS Contrast?	N/A
N/A	Landing Slope (%)	N/A	N/A	DWS Length (in)	N/A
N/A	Landing X Slope (%)	N/A	N/A	DWS Full Width?	N/A
N/A	Landing Curb? (Y/N)	N/A	N/A	DWS Offset (in)	N/A
N/A	Shared Landing?	N/A			
N/A	Gutter Ponding?	N/A	N/A	Gutter Slope (%)	N/A
N/A	Gutter Lip Ht (in)	N/A	N/A	Gutter X Slope (%)	N/A
N/A	Painted X Walk1?	Yes	N/A	Painted X Walk2?	N/A
	X Walk 1 Direction	To NE		X Walk 2 Direction	N/A
N/A	X Walk 1 Width (in)	102.0	N/A	X Walk 2 Width (in)	N/A
	X Walk 1 Slope (%)	4.5		X Walk 2 Slope (%)	N/A
	X Walk 1 X Slope (%)	1.9		X Walk 2 X Slope (%)	N/A

N/A	Ramp inside XWalk1?	Yes	N/A	Ramp inside XWalk2?	N/A
	Road Slope (%)	N/A	N/A	Clear Space?	N/A
	Road X Slope (%)	N/A	N/A	Clear Space to XWalk (in)	N/A
N/A	Any Obstructions?	N/A	N/A	Storm Grate/Utility Hazard?	N/A
	Obstruction Type			Storm Grate/Utility Type	
		N/A			N/A
			Yes	Surface Condition? (G/P)	Good

Remove & Replace Entire Ramp.

Total Cost: \$ 1850.00
