Intersection ID: 17350	Main Street: HILLSIDE_AV	Cross Street: PADDOCK_CR	Location:	SE
ADA ID: 427AE435E8F4	Ramp Type: PerpDiag	Initial Pass/Fail: Fail	Overall Compliance: No	Severity Score: 33.75

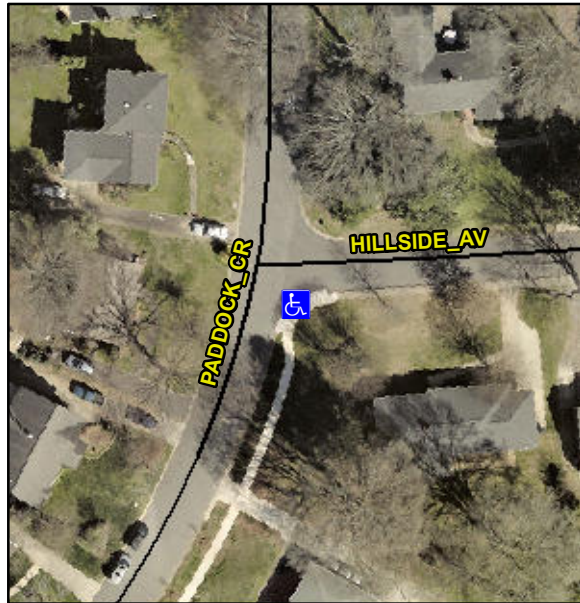
**Not Found, R304.5.1, R304.2.2,
R304.5.3**

Compliance	Description	Data	Compliance	Description	Data
N/A	Ramp Length (in)	48.0	No	Ramp Slope (%)	9.7
No	Ramp Width (in)	47.5	No	Ramp XSlope (%)	6.8
N/A	Flare Type LT	N/A	N/A	Flare Type RT	N/A
N/A	Flare Slope LT (%)	N/A	N/A	Flare Slope RT (%)	N/A
N/A	Flare Traversable LT?	N/A	N/A	Flare Traversable RT?	N/A
N/A	Landing Length (in)	N/A	N/A	DWS Provided?	N/A
N/A	Landing Width (in)	N/A	N/A	DWS Contrast?	N/A
N/A	Landing Slope (%)	N/A	N/A	DWS Length (in)	N/A
N/A	Landing X Slope (%)	N/A	N/A	DWS Full Width?	N/A
N/A	Landing Curb? (Y/N)	N/A	N/A	DWS Offset (in)	N/A
N/A	Shared Landing?	N/A			
N/A	Gutter Ponding?	N/A	N/A	Gutter Slope (%)	N/A
N/A	Gutter Lip Ht (in)	N/A	N/A	Gutter X Slope (%)	N/A
N/A	Painted X Walk1?	No	N/A	Painted X Walk2?	No
	X Walk 1 Direction	To NE		X Walk 2 Direction	To NW
N/A	X Walk 1 Width (in)	N/A	N/A	X Walk 2 Width (in)	N/A
	X Walk 1 Slope (%)	4.5		X Walk 2 Slope (%)	3.0
	X Walk 1 X Slope (%)	2.1		X Walk 2 X Slope (%)	2.6

N/A	Ramp inside XWalk1?	N/A	N/A	Ramp inside XWalk2?	N/A
	Road Slope (%)	2.9	N/A	Clear Space?	N/A
	Road X Slope (%)	4.6	N/A	Clear Space to XWalk (in)	N/A
N/A	Any Obstructions?	N/A	N/A	Storm Grate/Utility Hazard?	N/A
	Obstruction Type			Storm Grate/Utility Type	
		N/A			N/A
			Yes	Surface Condition? (G/P)	Good

Possible Solutions:

Remove & Replace Curb Ramp With Two New Directional Ramps or Equivalent.

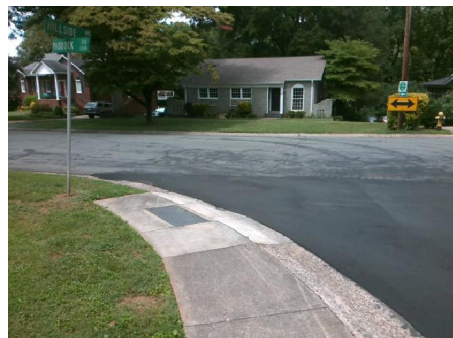
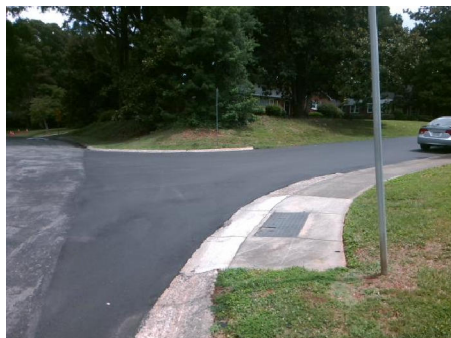
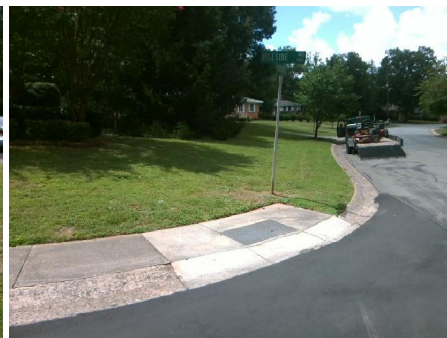
Street 1 Name	HILLSIDE AV
Stop Condition-Street 2	StopSign
Street 2 Name	PADDOCK CR
Stop Condition-Street 1	None
