# Access Compliance Report

## Public Rights-of-Way

### (Curb Ramps)

| Intersection ID: N/A | Main Street: BALLANTYNE_VILLAGE_WY | Cross Street: WINSLET_DR | Location: NW |

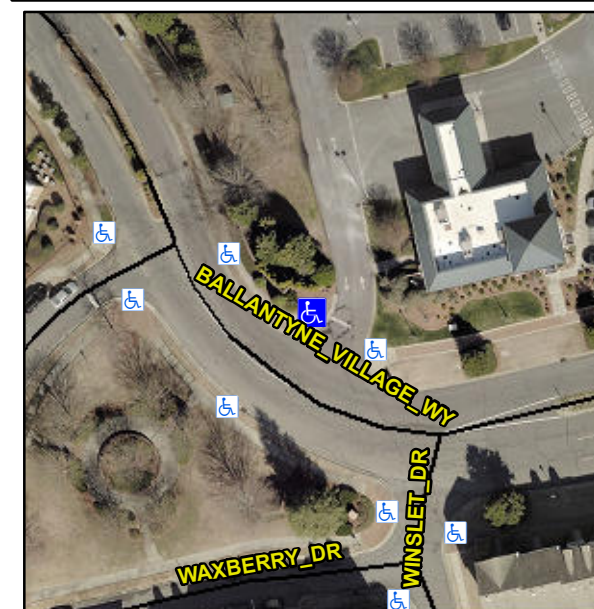
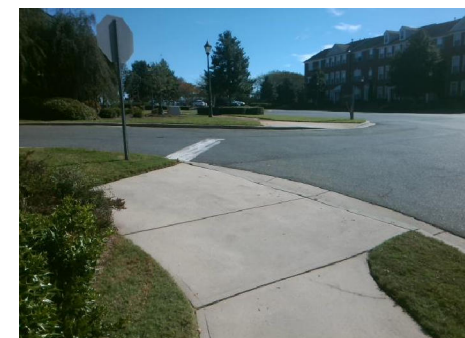
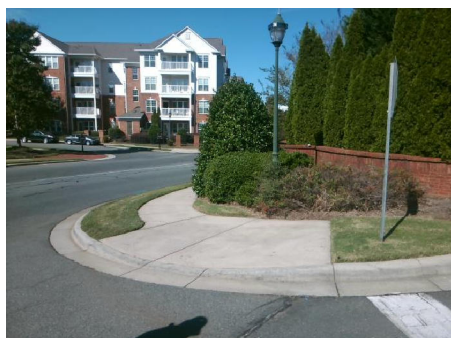
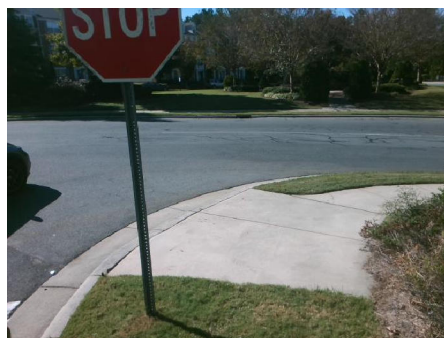
| ADA ID: 427EF1CCAF29 | Ramp Type: BlendTrans2 | Initial Pass/Fail: Fail | Overall Compliance: No |

| Compliance | Description | Data | Compliance | Description | Data |
|---|---|---|---|---|---|
| N/A | Ramp Length (in) | 112.0 | Yes | BlendTrans Slope (%) | 1.4 |
| No | Ramp Width (in) | 39.0 | No | BlendTrans XSlope (%) | 14.1 |

**Remove & Replace Curb Ramp With Two New Directional Ramps or Equivalent.**

**R304.5.1, R304.5.3**

Total Cost: \$ 3200.00
